DE Home Inspections

Property Inspection Report

Client(s): **Client**
 Property address: **Client**
 Inspection date: **Thursday, January 01, 2009**

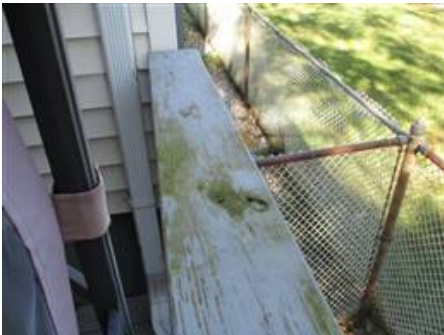
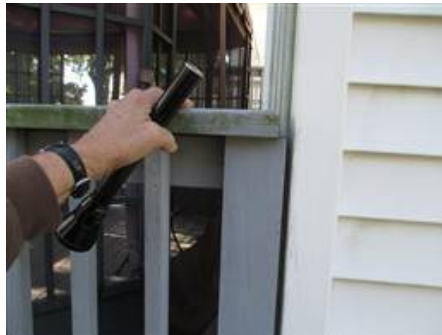
Guardrails at one or more locations were loose and wobbly. Recommend that a qualified contractor replace or repair guardrails per standard building practices.

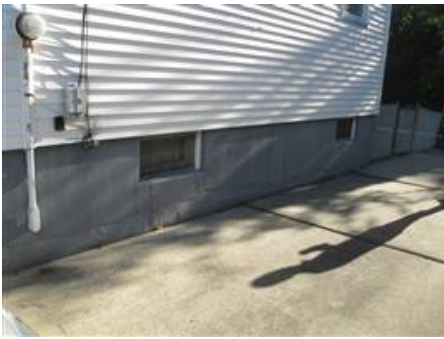
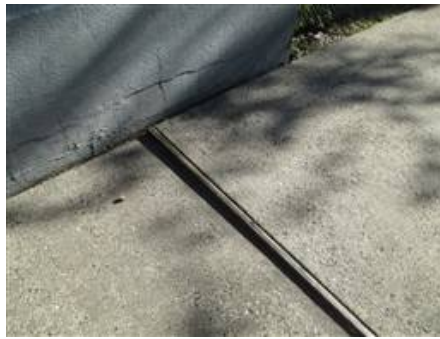
Cracks, holes, settlement, heaving and/or deterioration resulting in trip hazards were found in the driveway. For safety reasons, recommend that a qualified contractor repair as necessary.

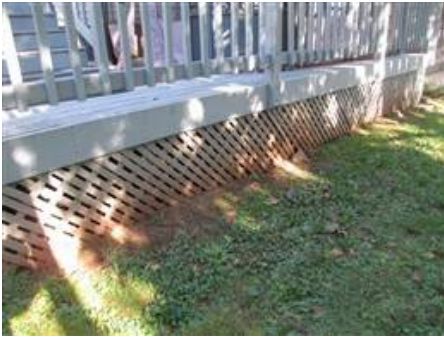
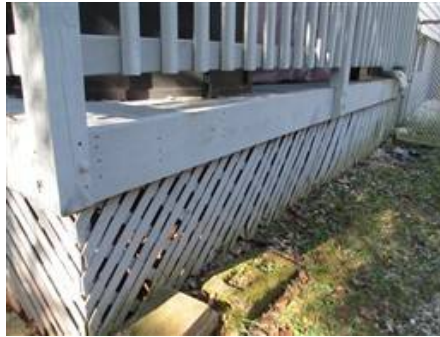
Most areas of the deck substructure were inaccessible due to limited space below, permanently installed skirting. These areas couldn't be evaluated and are excluded from the inspection.

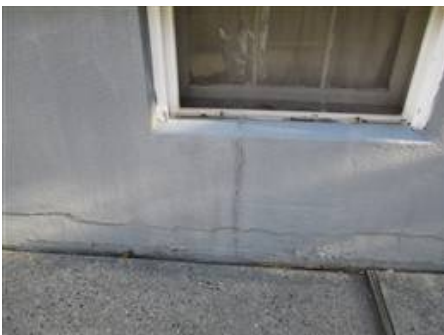
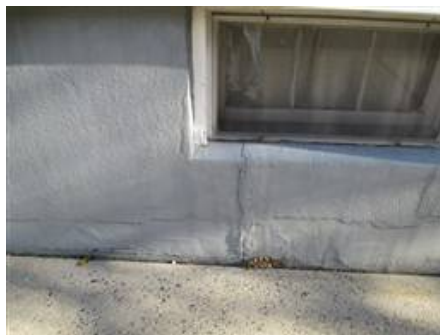
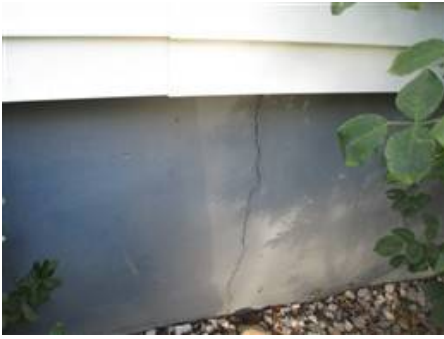
One or more minor cracks (1/8 inch or less) were found in the foundation. These didn't appear to be a structural concern, but recommend sealing them to prevent water infiltration and monitor them in the future. Numerous products exist to seal such cracks including hydraulic cement, non-shrinking grout, resilient caulks and epoxy sealants.

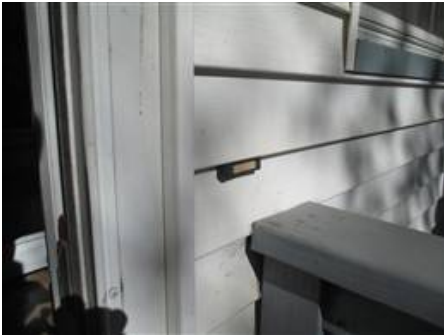
Photo 6-1

The back door's doorbell appeared to be inoperable. Recommend that a qualified person repair as necessary.

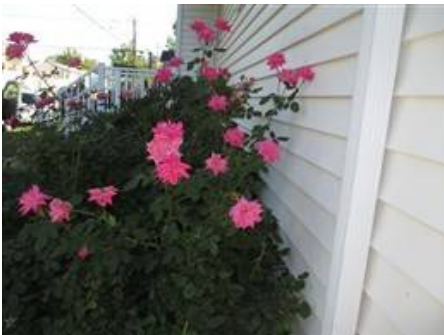
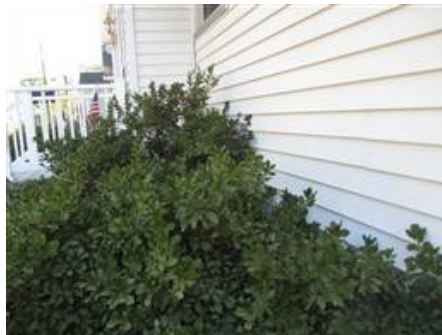
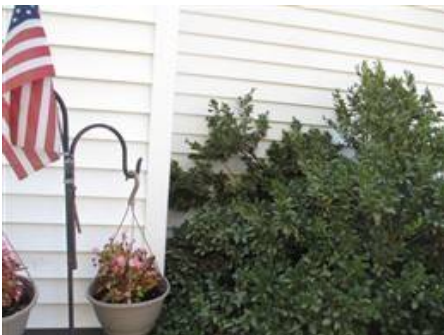
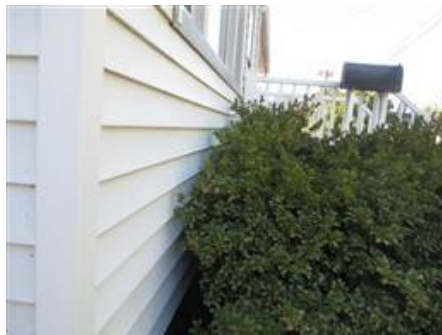
Vegetation such as trees, shrubs and/or vines was in contact with or close to the building exterior. Vegetation can serve as a pathway for wood-destroying insects and can retain moisture against the exterior after it rains. This is a conducive condition for wood-destroying organisms. Recommend pruning, moving or removing vegetation as necessary to maintain at least 6 inches of space between it and the building exterior. A 1-foot clearance is better.

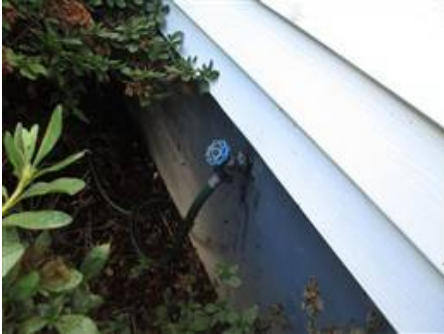
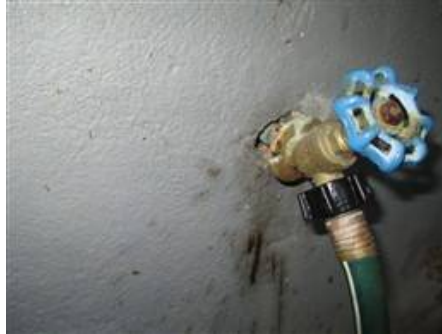
Caulk was missing in some areas. For example, at wall penetrations. Recommend that a qualified person renew or install caulk as necessary. Where gaps are wider than 1/4 inch, an appropriate material other than caulk should be used. For more information, visit: http://www.reporthost.com/docs/FPL_Caulking_Ins_Out.pdf

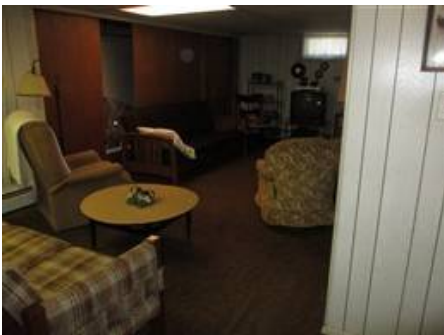
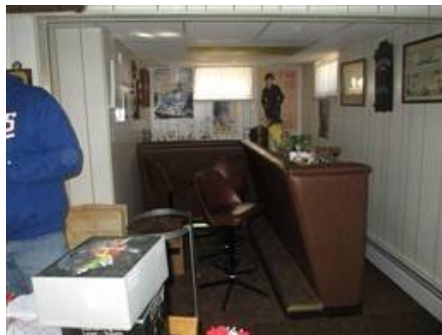
Many areas were not evaluated due to lack of access from finished walls and ceiling. These areas are excluded from the inspection.

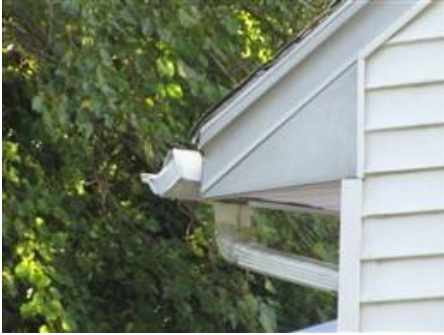
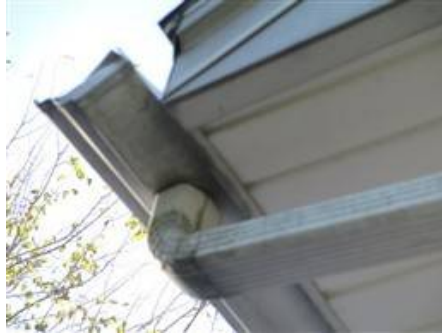
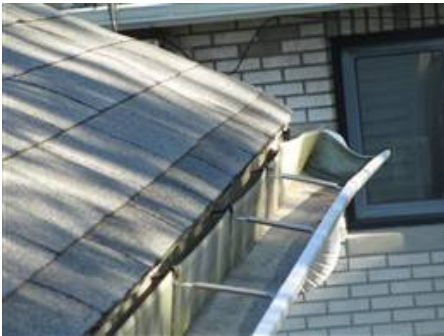
One or more gutters were loose. Rainwater can come in contact with the building exterior or accumulate around the building foundation as a result. This is a conducive condition for wood-destroying organisms. Recommend that a qualified person repair as necessary.

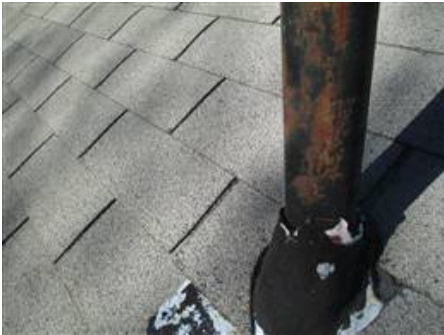
Photo 12-1

Sealant was used at one or more roof penetrations (e.g. pipes, vents, chimneys) rather than flashing. Sealant is not required for most roof penetrations when installations of such items are done professionally and per standard building practices. The presence of sealant suggests that work was performed by someone who was not a qualified contractor. The sealant will be a maintenance issue in the future since it must be renewed periodically. Recommend that a qualified contractor repair where necessary and per standard building practices. For example, by removing sealant and installing flashing.

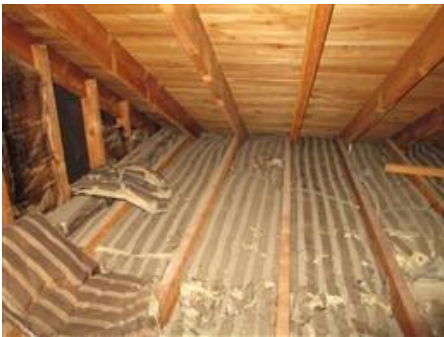
Photo 14-1

The facing on fiberglass batt insulation in the was exposed. In most cases, the facing is flammable and poses a fire hazard. Also, the facing typically acts as a vapor barrier, and if located away from the interior surfaces can trap moisture from condensation in the cavity between the facing and the interior spaces. This can be a conducive condition for wood-destroying organisms. Recommend that a qualified person repair as necessary. For example, by reinstalling or replacing insulation per standard building practices and per the manufacturer's instructions.

Note that the inspector was unable to evaluate areas obscured by insulation to determine if any damage (e.g. rot, insect infestation) has already occurred due to moisture accumulation. When insulation repairs are made, recommend that the exposed structure be evaluated and repairs made if necessary.

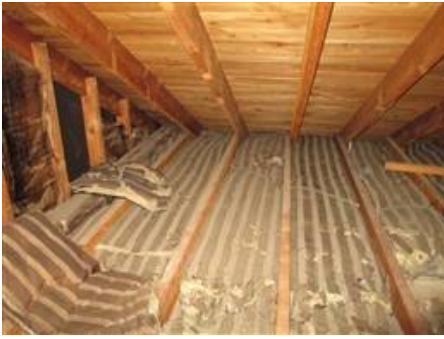
Photo 17-1

The ceiling insulation installed in the attic was substandard and appeared to have an R rating that's significantly less than current standards (R-38). Heating and cooling costs will likely be higher due to poor energy efficiency. Recommend that a qualified contractor install insulation for better energy efficiency and per standard building practices.

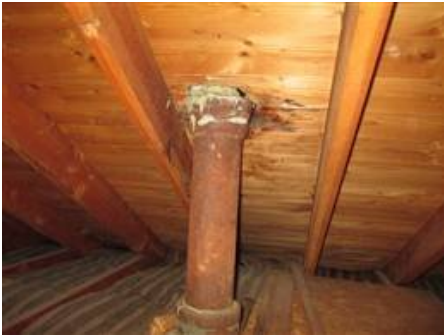
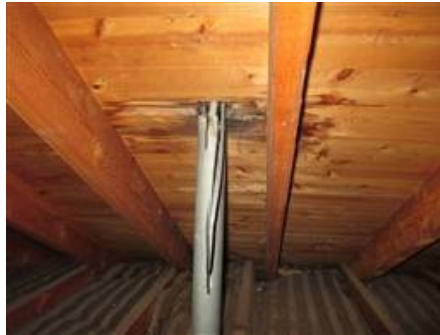
What appeared to be past water stains were visible on the roof structure at one or more locations in the attic. However, no elevated levels of moisture were found at these stains during the inspection. The stains may have been caused by a past leak. Recommend asking the property owner about past leaks. Monitor these areas in the future, especially after heavy rains to determine if active leaks exist. If leaks are found, recommend that a qualified contractor evaluate and repair as necessary.

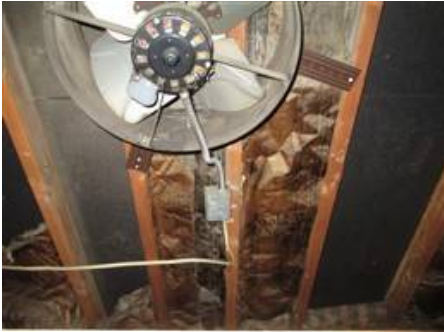
Photo 19-1

An attic exhaust fan was installed and controlled by a thermostat. However the inspector was unable to operate the fan or fully evaluate it because either the temperature was too cool to activate the thermostat. It is excluded from this inspection.

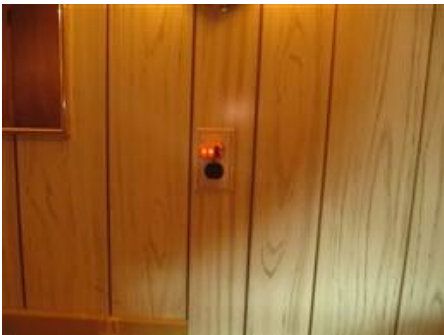
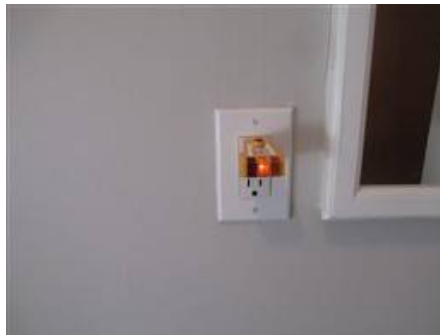
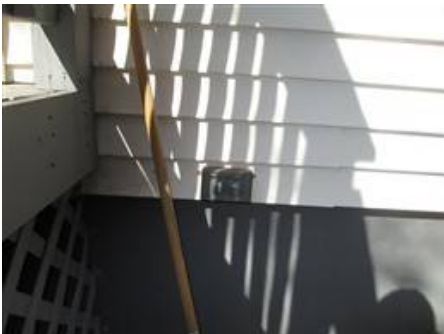
One or more electric receptacles (outlets) at the bathroom(s), exterior had no visible ground fault circuit interrupter (GFCI) protection, or the inspector was unable to determine if GFCI protection was present. If not GFCI-protected, receptacles in wet areas pose a shock hazard. Recommend that a qualified electrician evaluate and install GFCI protection if necessary and per standard building practices. General guidelines for GFCI-protected receptacles include the following locations:

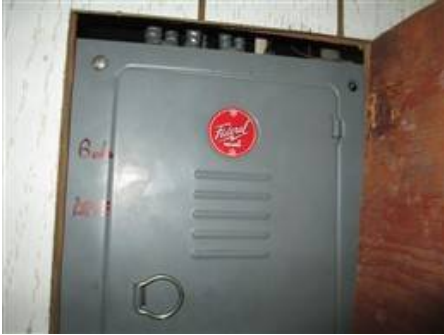
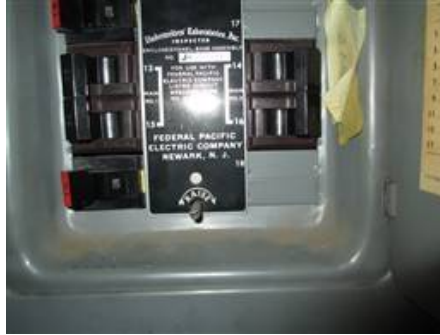
Panel was manufactured by the Federal Pacific Electric company and used "Stab-Lok" circuit breakers. There is significant evidence that both double and single pole versions of these circuit breakers fail by not tripping when they are supposed to. However, in 2011 the Consumer Products Safety Commission (CPSC) closed an investigation into this product because they did not have enough data to establish that the circuit breakers pose a serious risk of injury to consumers. Regardless, and due to other evidence of safety issues, recommend that a qualified electrician carefully evaluate all Federal Pacific panels and make repairs as necessary. Consider replacing Federal Pacific panels with modern panels that offer more flexibility for new, safer protective technologies like ground fault circuit interrupters (GFCIs) and arc fault circuit interrupters (AFCIs). For more information, visit:

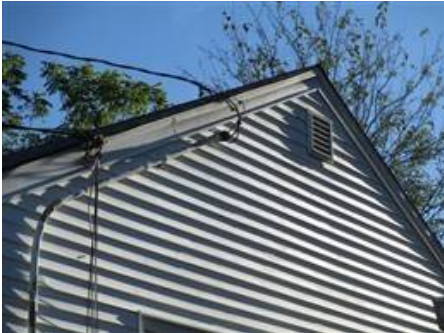
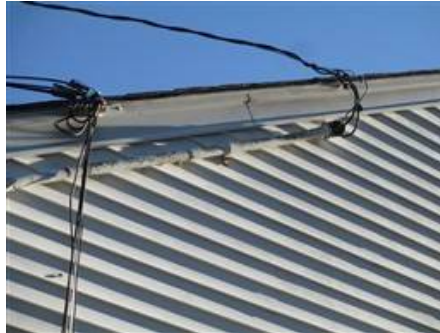
The service drop wires had no drip loop where they attached to the service mast, or the drip loop was substandard. This can result in water entering electric panels, and is a potential shock hazard. Recommend that a qualified electrician repair per standard building practices.

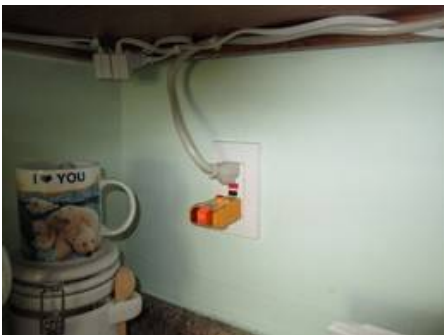
Photo 23-1

One or more ground fault circuit interrupter (GFCI) type receptacles (outlets) had an open ground. GFCI receptacles will work (trip) without a ground; but a 3-slot receptacle on an open ground circuit can result in appliances that require a ground can be used without one. This is a potential shock hazard. Recommend that a qualified electrician upgrade circuits that require GFCI protection (e.g. in wet areas) with grounded wiring per standard building practices.

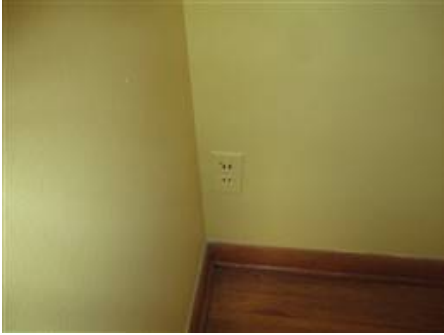
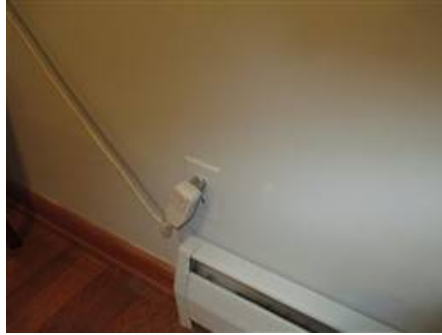
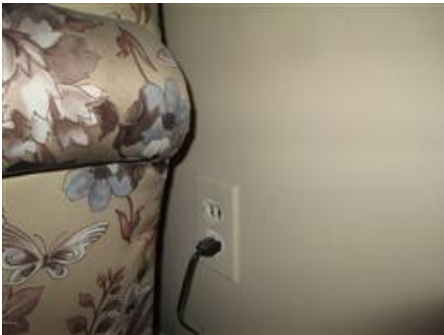
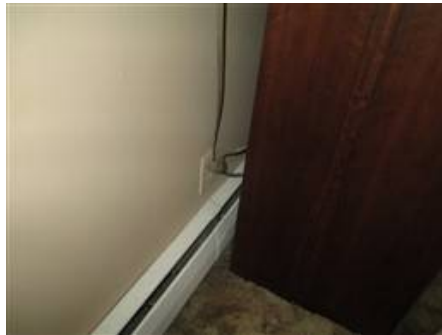
2-slot receptacles (outlets) rather than 3-slot, grounded receptacles were installed in one or more areas. These do not have an equipment ground and are considered unsafe by today's standards. Appliances that require a ground should not be used with 2-slot receptacles.

Examples of such appliances include computers and related hardware, refrigerators, freezers, portable air conditioners, clothes washers, aquarium pumps, and electrically operated gardening tools. The client should be aware of this limitation when planning use for various rooms, such as an office. Upgrading to grounded receptacles typically requires installing new wiring from the main service panel or sub-panel to the receptacle(s), in addition to replacing the receptacle(s). Consult with a qualified electrician about upgrading to 3-wire, grounded circuits.

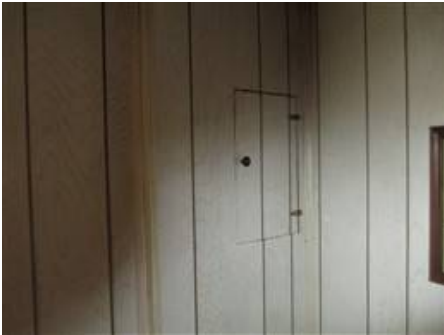
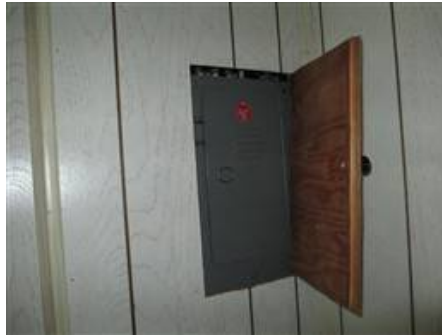
The inspector was unable to open and evaluate main panel because the cover was paneled over and blocking access. The panel is excluded from this inspection. Recommend that repairs, modifications and/or cleanup should be made as necessary so panels can be opened and fully evaluated.

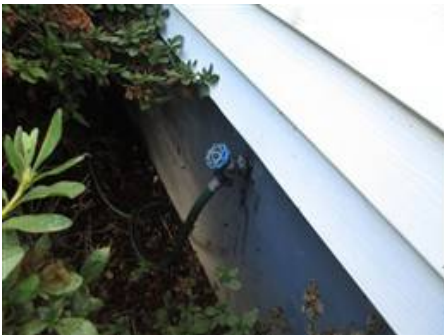
Photo 26-1

One or more hose bibs (outside faucets) appeared to be inoperable. No water flowed from the bib(s) when turned on. This may be due to a shut-off valve being turned off. Note that the inspector does not operate shut-off valves. Recommend consulting with the property owner about inoperable hose bibs, and if necessary have a qualified plumber make repairs.

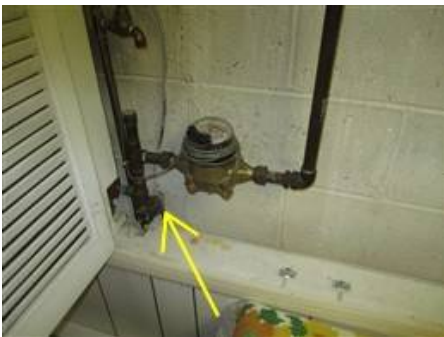
Photo 27-1

The copper water service pipe was embedded in concrete or masonry where it was routed through the foundation, and no protection from damage due to thermal expansion was visible. Copper pipes embedded in concrete or masonry should be wrapped with an approved tape or installed through a sleeve for abrasion protection. Recommend that a qualified contractor repair per standard building practices.

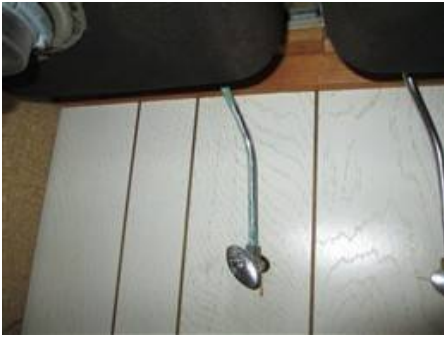
Significant corrosion or rust was found at one or more water supply valves. This can indicate past leaks, or that leaks are likely to occur in the future. Recommend that a qualified plumber repair as necessary. For example, by replacing valves or fittings.

Photo 28-1
Bar Sink

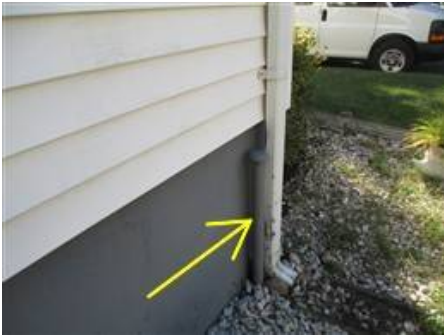
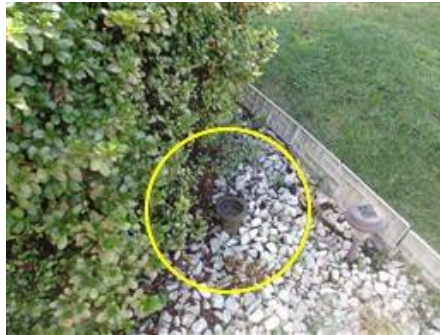
Either the inspector found evidence of an underground oil storage tank in use for the heating system, or was informed that such a tank was in use. The estimated lifespan for most buried tanks is 10-15 years, and older tanks are at risk of leaking. When leaks occur, the surrounding ground can become contaminated and require expensive mitigation. Recommend attempting to determine the age of the tank and review service records if possible. Also recommend that a qualified contractor or full-service oil provider test the tank for leaks and for water in the bottom. For more information, visit:

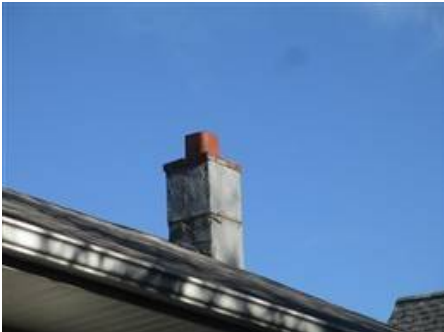
Photo 32-1

No spark screen or rain cap was installed at one or more chimney flue terminations. Spark screens reduce the chance of embers exiting the flue and causing fires. They also prevent wildlife (e.g. birds, rodents, raccoons) from entering flues. Rain caps prevent water from entering flues, mixing with combustion deposits and creating caustic chemicals which can corrode flues. They also prevent damage to masonry from freeze-thaw cycles and prevent metal components (e.g. dampers, metal firebox liners) from rusting. Recommend that a qualified person install rain caps with spark screens per standard building practices where missing.

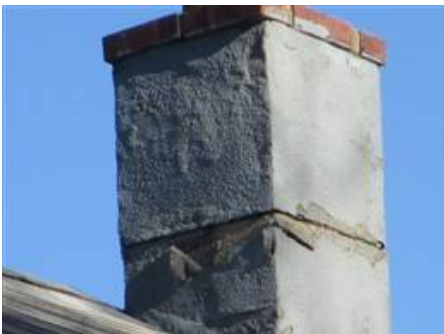
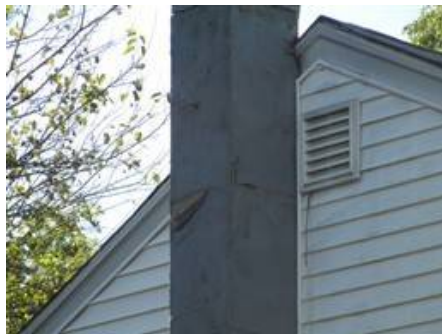
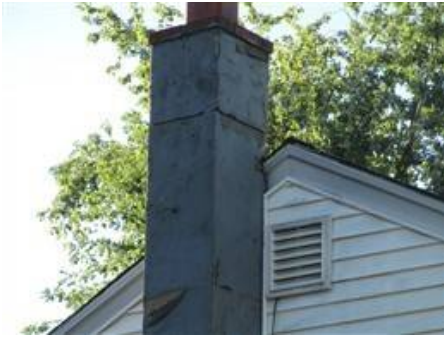
The brick chimney had some deterioration. For example, loose or missing mortar, cracked, broken, loose or spalled bricks. Loose bricks can pose a safety hazard, and deteriorated masonry can allow water to infiltrate the the chimney structure and cause further damage. Recommend that a qualified contractor repair as necessary.

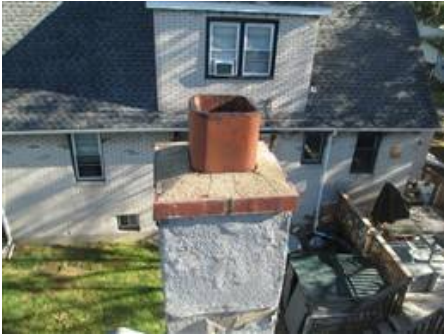
Photo 34-1

The masonry chimney crown was cracked. Crowns are meant to keep water off of the chimney structure and prevent damage from freeze-thaw cycles. Chimney crowns are commonly constructed by mounding concrete or mortar on the top chimney surface, however this is substandard. A properly constructed chimney crown should:

Recommend that a qualified contractor repair or replace crowns as necessary, and per standard building practices.

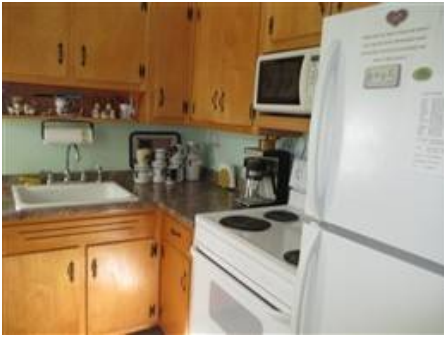
Photo 35-1

No exhaust hood was installed over the cook top or range, and no wall-mounted exhaust fan was found nearby. This can be a nuisance for odor and grease accumulation. Where a gas-fired range or cook top is installed, carbon monoxide and excessive levels of moisture can accumulate in living spaces. Lighting may also be inadequate. Recommend that a qualified contractor install a vented and lighted range hood, with the exhaust fan ducted outdoors.

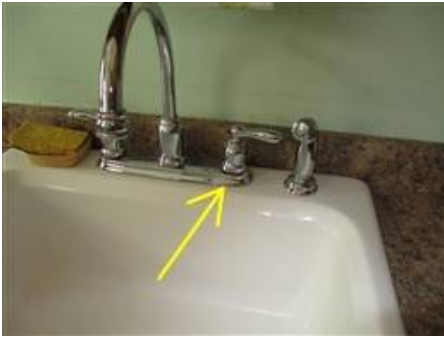
Photo 36-1

The sink faucet did not function properly in that the cold water handle did not shut off securely. Recommend that a qualified person repair as necessary.

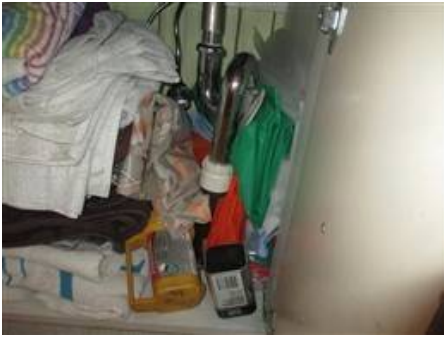
Photo 38-1

The sink drain pipe at location #B used an S-trap rather than a P-trap. Siphons and sudden flows of water in S-Traps can drain all the water out of the trap, leaving it dry. Sewer gases can then enter living areas. Recommend that a qualified plumber repair per standard building practices.

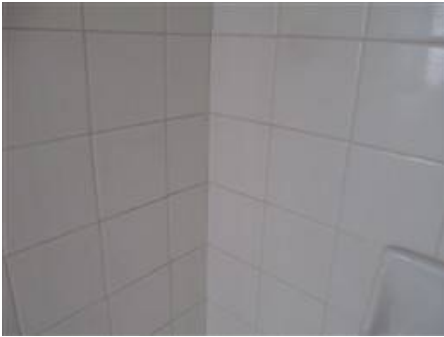
Photo 39-1

Grout in the bathtub surround at location #A was deteriorated (e.g. loose or missing grout) or substandard. Water can damage the wall structure as a result. Recommend that a qualified contractor repair as necessary.

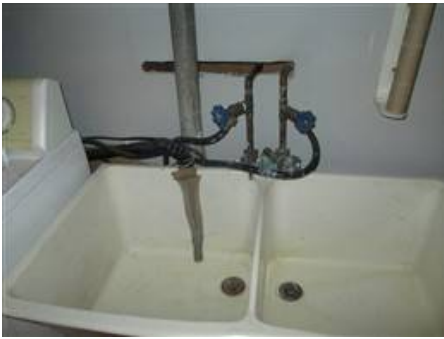
Photo 40-1

Rubber water supply hoses were installed at the clothes washer. These hoses are prone to bursting when deteriorated, which can result in flooding and significant water damage. Recommend upgrading to braided, stainless steel hoses.

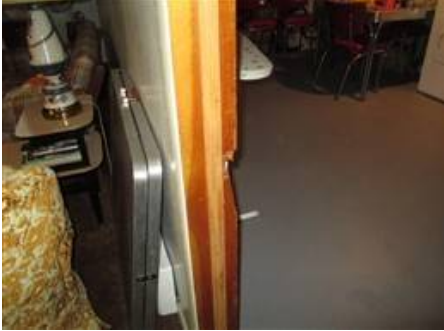
Photo 41-1

One or more interior doors jambs were damaged. Recommend that a qualified person replace or repair as necessary.

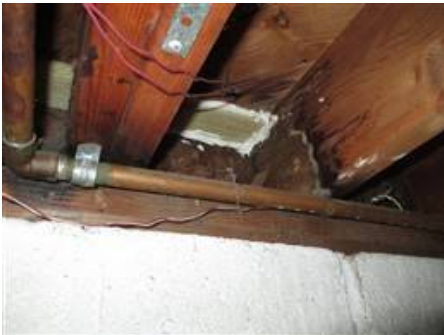
Photo 42-1

Patches or evidence of prior repairs were found in one or more walls or ceilings. Recommend asking the property owner about the repairs (e.g. why necessary, whether prior leaks have occurred).

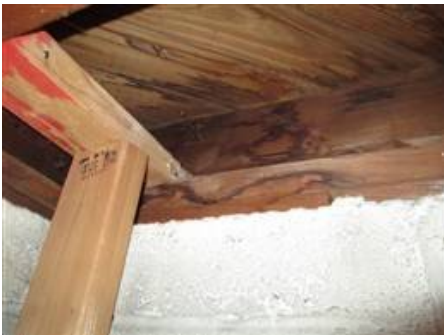
Stains were found in one or more ceiling areas. However, no elevated levels of moisture were found. The stain(s) may be due to past roof and/or plumbing leaks. Consult with the property owner and monitor the stained area(s) in the future, especially after heavy or prolonged rain. If elevated moisture is found in the future, then recommend that a qualified contractor evaluate and repair as necessary.

Photo 43-1
Basement - front wall

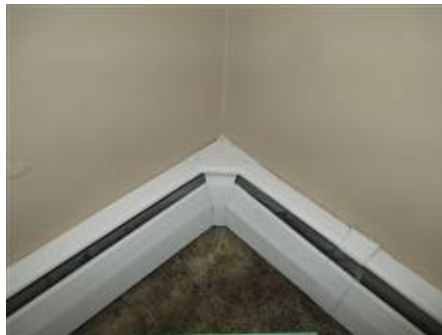
Photo 43-2
Area above front basement wall

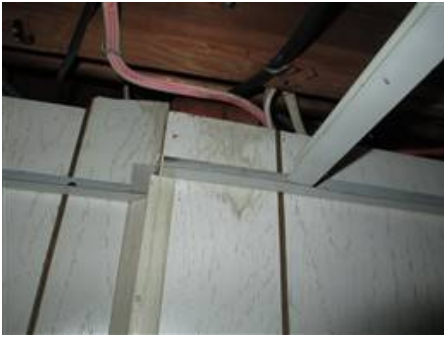
Photo 43-3
Above Main electric panel

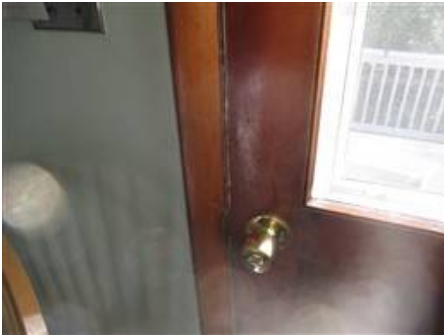
Photo 44-1

- 44) **i** One or more hinged exterior doors had no deadbolt lock installed and relied solely on the entry lockset for security. Recommend installing locksets on exterior doors where missing for added security.
