DE Home Inspections

Property Inspection Report

Client(s): **Client**
 Property address: **Client**
 Inspection date: **Thursday, January 01, 2009**

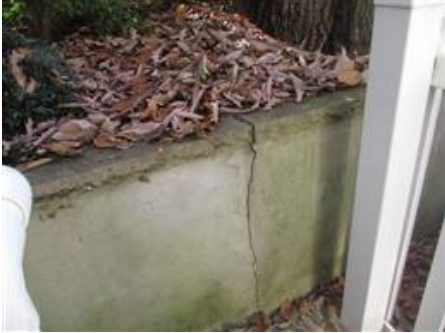
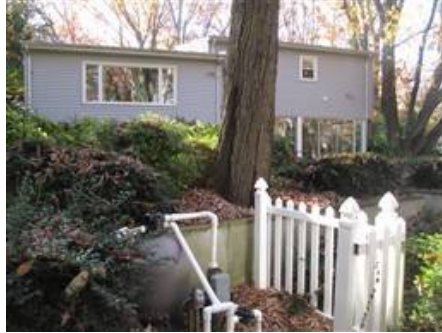
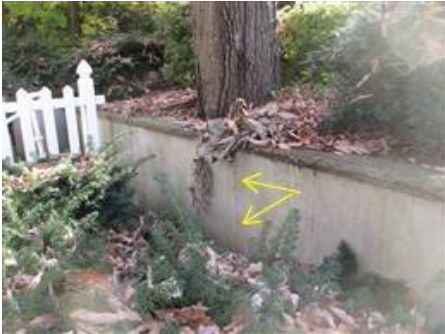
Significant cracks, deterioration, leaning and/or bowing were found in one or more retaining walls. Recommend that a qualified contractor evaluate and repair or replace sections as necessary. Note that some retaining walls, based on their height or size, may require evaluation by a structural engineer. Note that such repairs are often expensive.

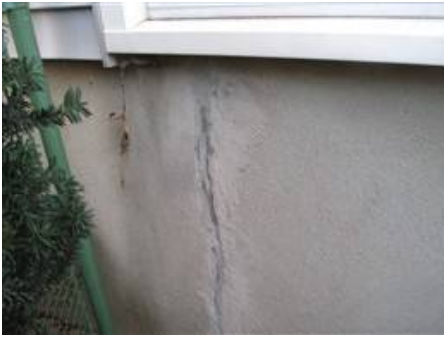
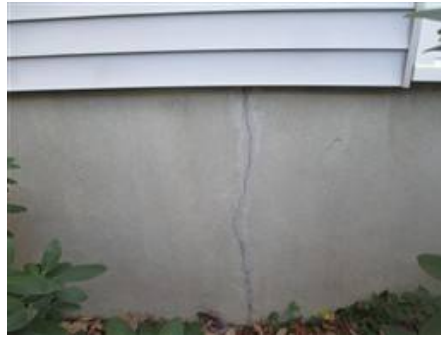
One or more minor cracks (1/8 inch or less) were found in the foundation. These didn't appear to be a structural concern, but recommend sealing them to prevent water infiltration and monitor them in the future. Numerous products exist to seal such cracks including hydraulic cement, non-shrinking grout, resilient caulks and epoxy sealants.

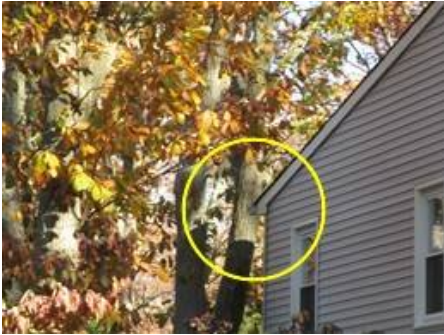
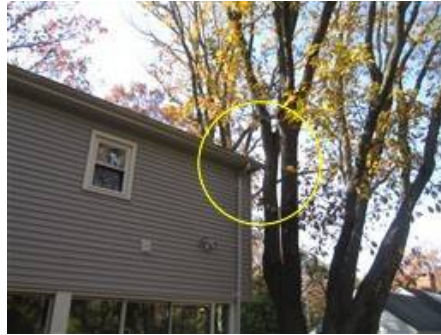
Trees were in contact with or were close to the building at one or more locations. Damage to the building can occur, especially during high winds. Recommend that a qualified tree service contractor or certified arborist remove trees as necessary to prevent damage to the building exterior.

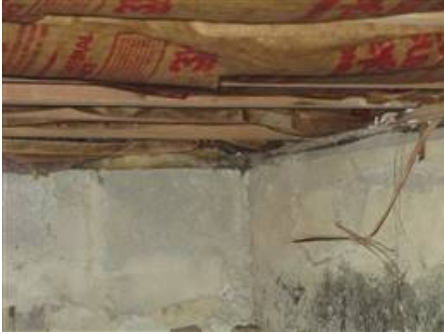
Photo 8-1

The facing on fiberglass batt insulation in the crawl space was exposed. In most cases, the facing is flammable and poses a fire hazard. Also, the facing typically acts as a vapor barrier, and if located away from the interior surfaces can trap moisture from condensation in the cavity between the facing and the interior spaces. This can be a conducive condition for wood-destroying organisms. Recommend that a qualified person repair as necessary. For example, by reinstalling or replacing insulation per standard building practices and per the manufacturer's

instructions.

Note that the inspector was unable to evaluate areas obscured by insulation to determine if any damage (e.g. rot, insect infestation) has already occurred due to moisture accumulation. When insulation repairs are made, recommend that the exposed structure be evaluated and repairs made if necessary.

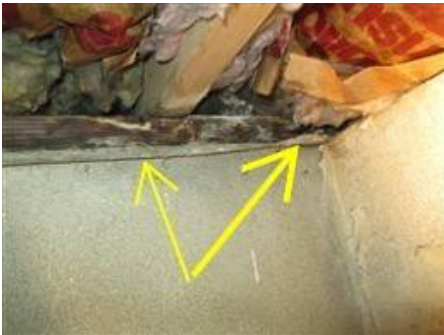
Photo 9-1

Stains were found on sill plate and joist in southwest corner. Although they were dry, this could indicate past water intrusion. Recommend that a qualified contractor evaluate and repair as necessary. All rotten wood should be replaced.

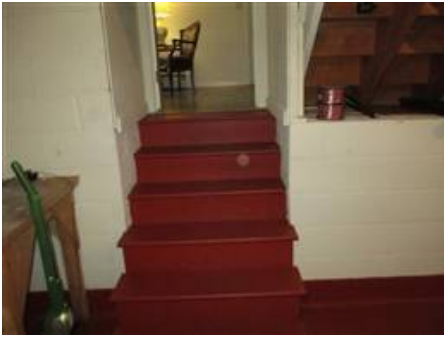
Photo 10-1

Handrails at one or more flights of stairs were missing. This is a potential fall hazard. Handrails should be installed at stairs with four or more risers or where stairs are greater than 30 inches high. Recommend that a qualified contractor install handrails where missing and per standard building practices.

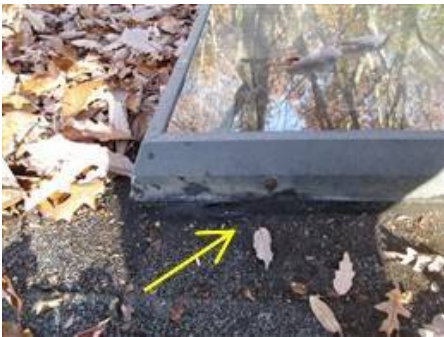
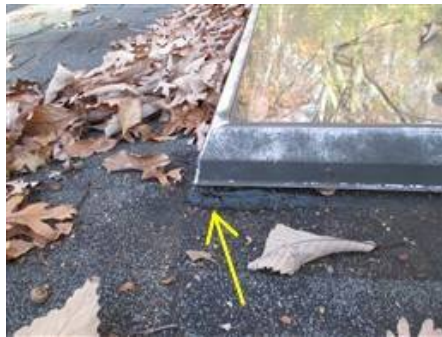
Caulking was deteriorated around one or more skylights. Consult with the property owner to determine if leaks have occurred, or if repairs have been made. Recommend that a qualified contractor evaluate and repair as necessary.

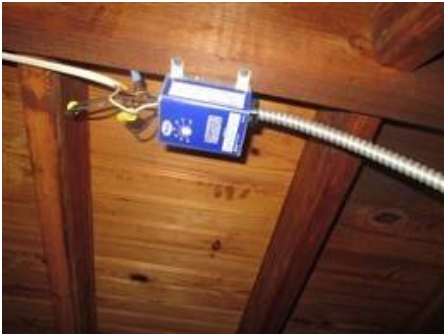
Photo 16-1

Several attic exhaust fans were installed and controlled by a thermostats. However the inspector was unable to operate them or fully evaluate because the temperature was too cool to activate the thermostats. They are excluded from this inspection.

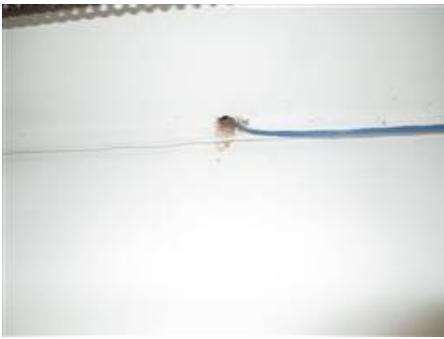
Photo 17-1

One or more gaps, holes were found in the attached garage walls or ceilings. Current standard building practices call for wooden-framed ceilings and walls that divide the house and garage to provide limited fire-resistance rating to prevent the spread of fire from the garage to the house. Recommend that a qualified person repair per standard building practices. For example, by patching openings or holes, firestopping holes or gaps with fire-resistant caulking, and/or installing fire-resistant wall covering (e.g. Type X drywall). For more information, visit:

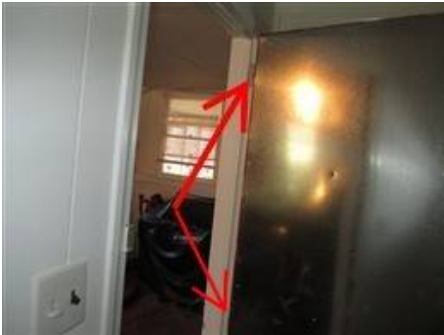
Photo 18-1

The self-closing device on the door between the garage and the house was missing. These devices are installed to keep the door closed to prevent possible fire and fumes from the garage from spreading to the house. Recommend that a qualified person repair as necessary.

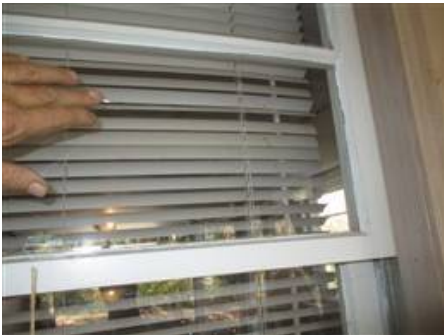
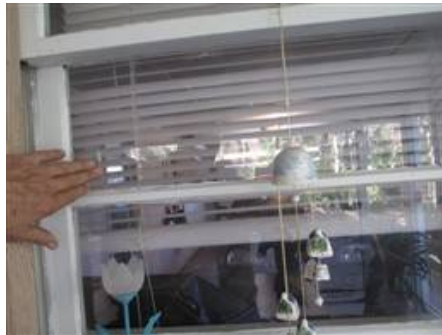
Glass in one or more windows was cracked, broken and/or missing. Recommend that a qualified contractor replace glass where necessary.

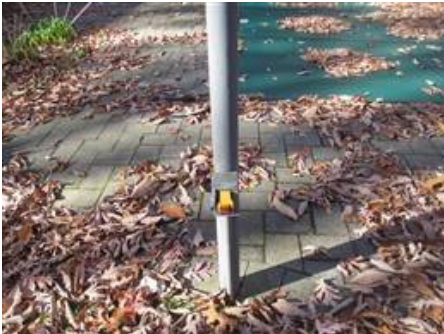
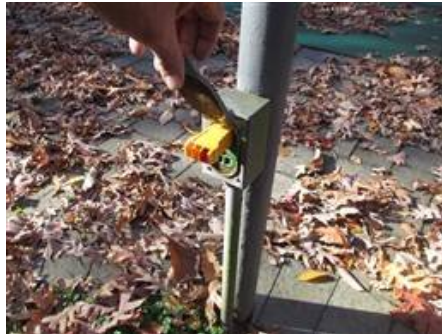
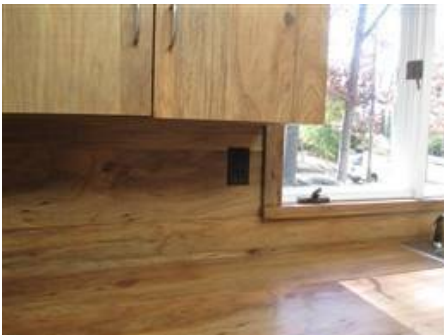
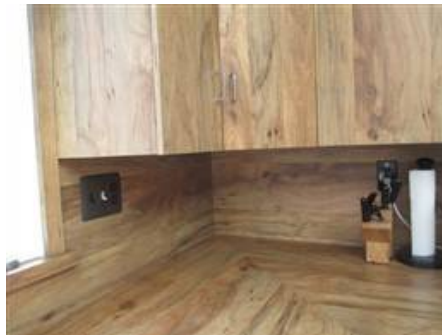
One or more electric receptacles (outlets) at the kitchen, pool had no visible ground fault circuit interrupter (GFCI) protection, or the inspector was unable to determine if GFCI protection was present. If not GFCI-protected, receptacles in wet areas pose a shock hazard. Recommend that a qualified electrician evaluate and install GFCI protection if necessary and per standard building practices. General guidelines for GFCI-protected receptacles include the following locations:

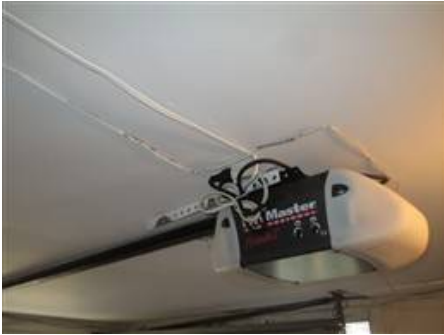
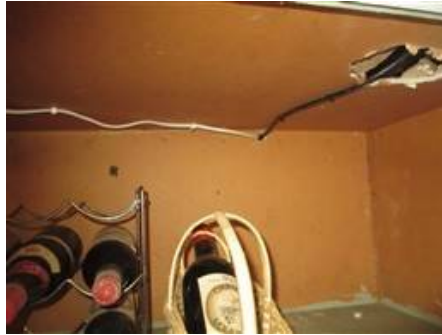
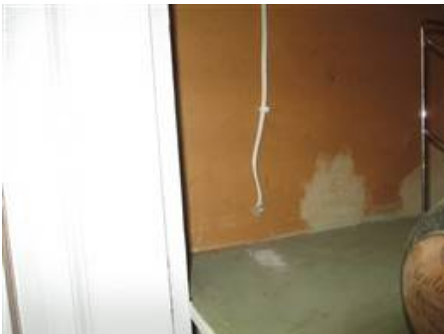
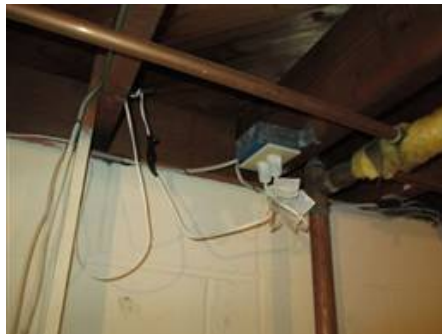
Extension cords were being used as permanent wiring at one or more locations. They should only be used for portable equipment on a temporary basis. Using extension cords as permanent wiring is a potential fire and shock hazard, and indicates that wiring is inadequate and needs updating. Extension cords may be undersized. Connections may not be secure resulting in power fluctuations, damage to equipment, overheating and sparks that could start a fire. Recommend that a qualified electrician repair per standard building practices and eliminate extension cords for permanently installed equipment.

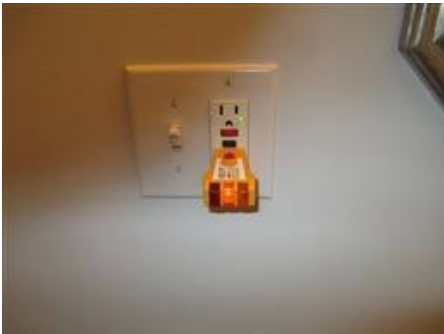
One or more ground fault circuit interrupter (GFCI) type receptacles (outlets) had an open ground. GFCI receptacles will work (trip) without a ground; but a 3-slot receptacle on an open ground circuit can result in appliances that require a ground can be used without one. This is a potential shock hazard. Recommend that a qualified electrician upgrade circuits that require GFCI protection (e.g. in wet areas) with grounded wiring per standard building practices.

Photo 23-1
Basement powder room

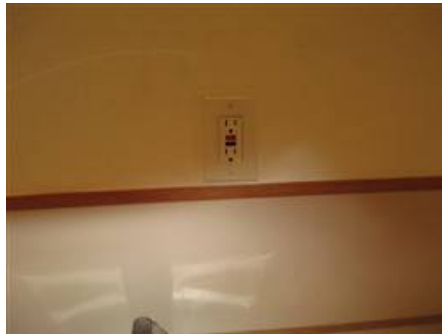
Photo 23-2
Bar sink area

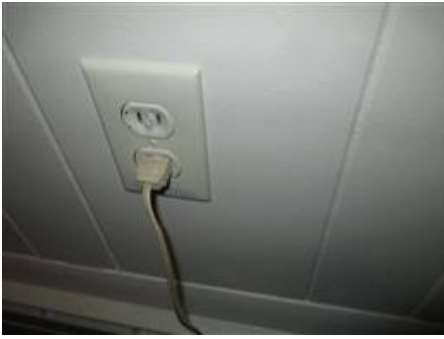
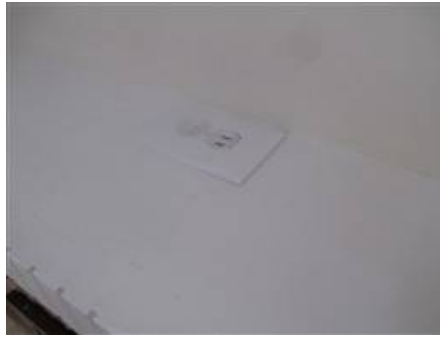
2-slot receptacles (outlets) rather than 3-slot, grounded receptacles were installed in one or more areas. These do not have an equipment ground and are considered unsafe by today's standards. Appliances that require a ground should not be used with 2-slot receptacles. Examples of such appliances include computers and related hardware, refrigerators, freezers, portable air conditioners, clothes washers, aquarium pumps, and electrically operated gardening tools. The client should be aware of this limitation when planning use for various rooms, such as an office. Upgrading to grounded receptacles typically requires installing new wiring from the main service panel or sub-panel to the receptacle(s), in addition to replacing the receptacle(s). Consult with a qualified electrician about upgrading to 3-wire, grounded circuits.

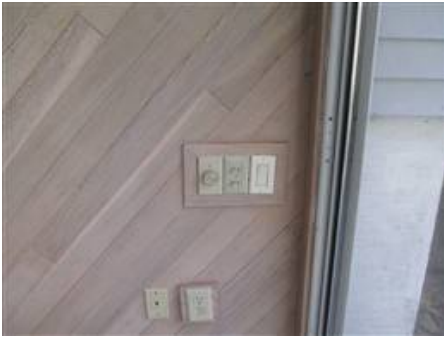
Photo 25-1

Could not determine what one or more wall switches controlled. Recommend discussing this with homeowner to determine their function.

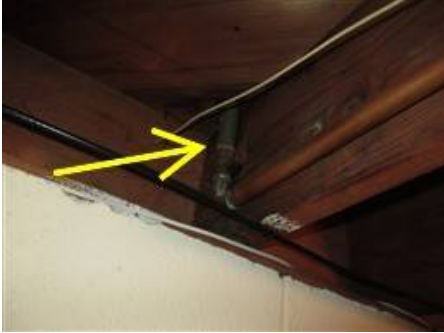
Photo 26-1

Some or all of the water supply and drain or vent pipes were made of galvanized steel. Based on the age of this structure and the 40-60 year useful life of this piping, it will likely need replacing in the future. Leaks can develop, flooding and/or water damage may occur, flow can be restricted due to scale accumulating inside the piping, and water may be rusty. Note that it is beyond the scope of this inspection to determine what percentage of the piping is older, galvanized steel, as much of it is concealed in wall, floor and/or ceiling cavities. Recommend the following:

Southwest corner of basement

- Consulting with a qualified plumber about replacement options and costs
- Budget for replacement in the future
- Monitor these pipes for leaks and decreased flow in the future
- Consider replacing old, galvanized steel piping proactively

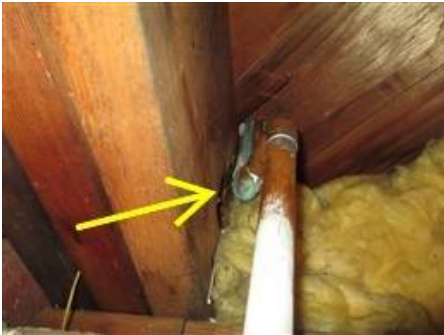
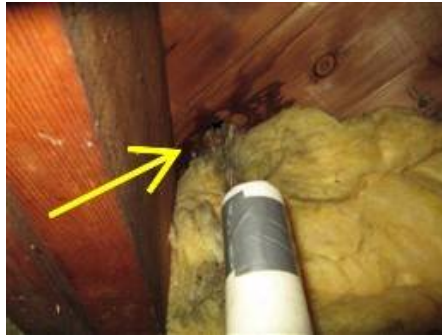
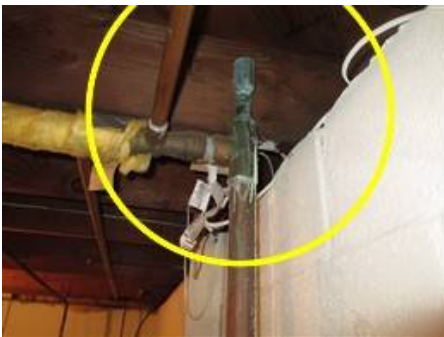
Corrosion was found in one or more distribution supply valves, fittings for the heating system. This can indicate past leaks, or that leaks are likely to occur in the future. Recommend that a qualified heating contractor or plumber evaluate and repair as necessary.

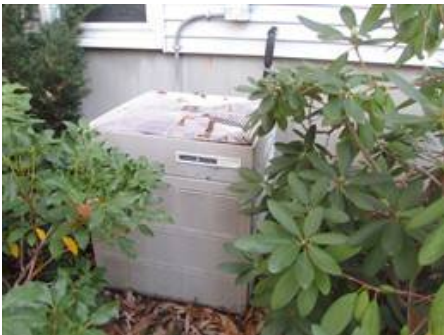
Photo 30-1

Vegetation such as trees, shrubs and/or vines were too close to the heat pump or air conditioning condensing unit. There should be at least 12 inches of clearance on all sides and at least 4-6 feet above. Inadequate clearance around and above can result in reduced efficiency, increased energy costs and/or damage to equipment. Recommend pruning and/or removing vegetation as necessary.

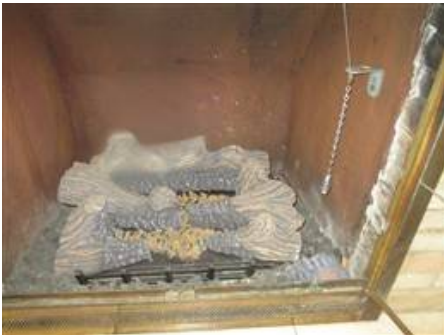
Photo 34-1

Recommend that the client review all available documentation for gas-fired fireplaces and stoves. Depending on how they are operated (for routine heating versus ambiance), such appliances normally need servicing annually or every few years. Consult with the property owner and/or a qualified specialist to determine if service is needed now.

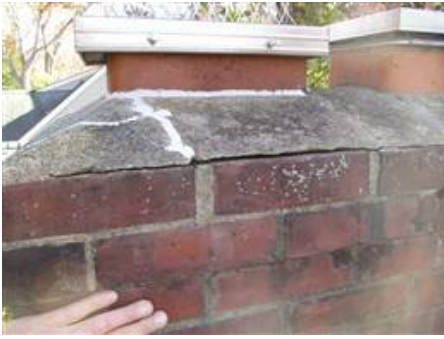
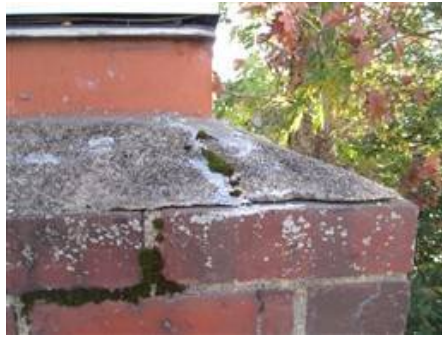
One or more masonry chimney crowns were cracked. Crowns are meant to keep water off of the chimney structure and prevent damage from freeze-thaw cycles. Chimney crowns are commonly constructed by mounding concrete or mortar on the top chimney surface, however this is substandard. A properly constructed chimney crown should:

- Be constructed using either precast concrete slabs, cast-in-place steel reinforced concrete, solid stone, or metal
- Be sloped down from the flue a minimum of 3 inches of fall per foot of run
- Extend a minimum of 2 1/2 inches beyond the face of the chimney on all sides
- Not directly contact the flue liner (if installed), with the gap filled with flexible caulk
- Have flashing installed between the bottom of the crown and the top of the brick chimney

Recommend that a qualified contractor repair or replace crowns as necessary, and per standard building practices.

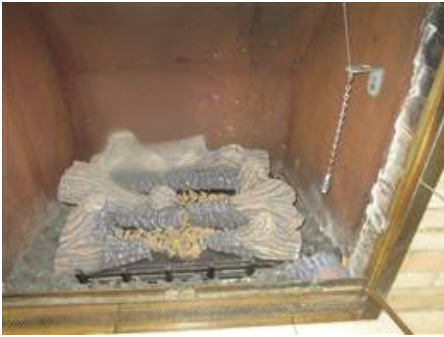
Photo 36-1

The gas fireplace or stove was not fully evaluated because the pilot light was off. The inspector only operates normal controls (e.g. on/off switch or thermostat) and does not light pilot lights or operate gas shut-off valves. Recommend that the client review all documentation for such gas appliances and familiarize themselves with the lighting procedure. If necessary, a qualified specialist should assist in lighting such appliances, and make any needed repairs.

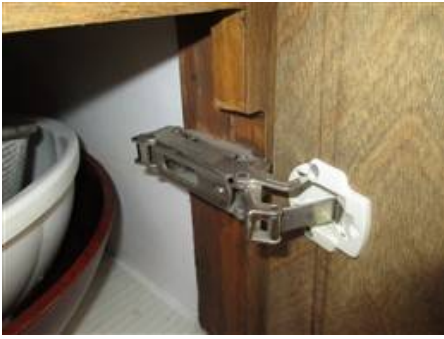
Photo 37-1

One or more cabinets, drawers and/or cabinet doors were damaged or deteriorated. Recommend that a qualified person repair or replace as necessary.

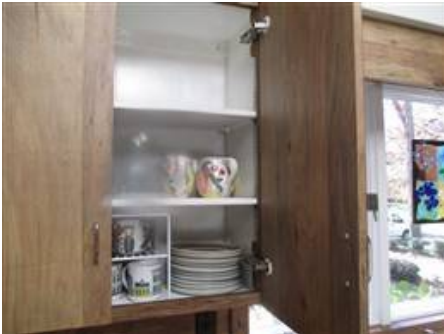
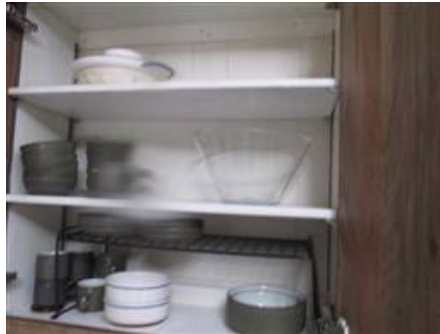
One or more cabinets were loose, or were secured with too few or substandard fasteners. An adequate number of appropriate fasteners should be used. For wall-hung cabinets, inadequate fasteners can pose a safety hazard if cabinets fall. Recommend that a qualified person repair as necessary.

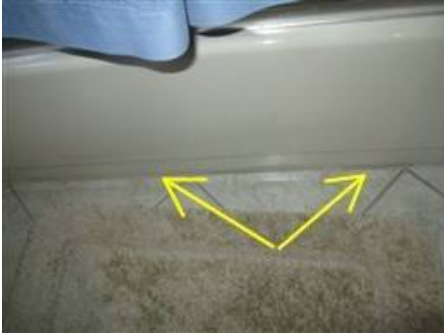
Gaps, no caulk, or substandard caulking were found between the bathtub and the floor at location(s) #E. Water may penetrate these areas and cause damage. Recommend that a qualified person re-caulk or install caulking as necessary.

Photo 41-1
Master Bathroom

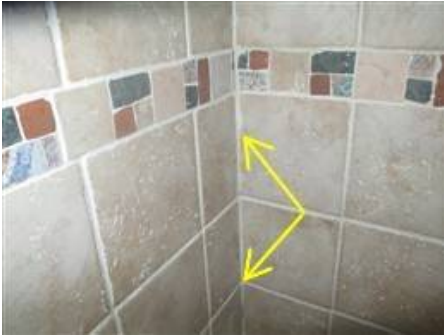
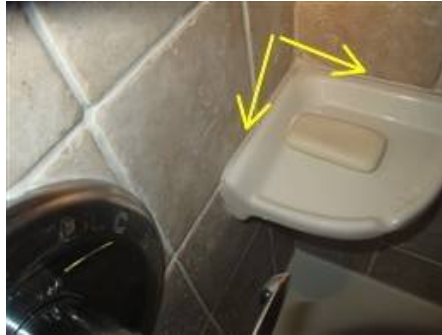
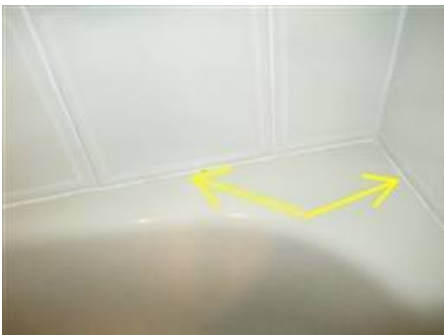
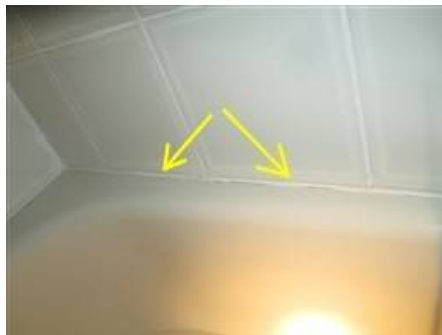
Tile and/or grout in the bathtub surround at location(s) #D, E was deteriorated (e.g. loose or cracked tiles, missing grout) or substandard. Water can damage the wall structure as a result. Recommend that a qualified contractor repair as necessary.

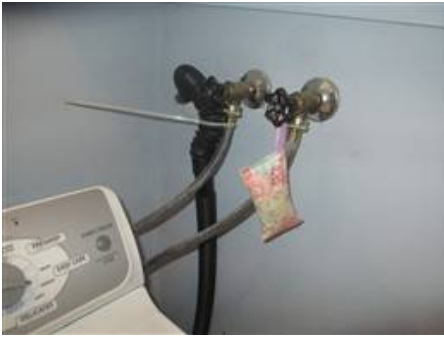
Photo 43-1

Rubber water supply hoses were installed at the clothes washer. These hoses are prone to bursting when deteriorated, which can result in flooding and significant water damage. Recommend upgrading to braided, stainless steel hoses.

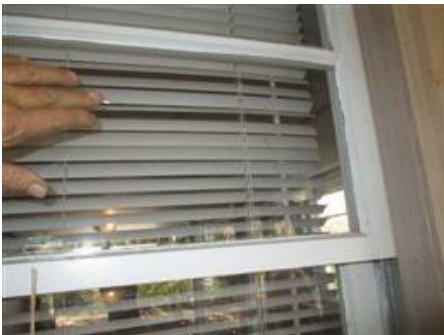
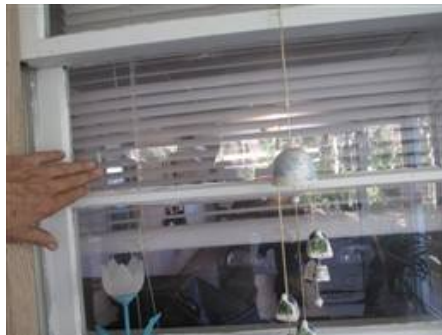
Glass in one or more windows was cracked, broken and/or missing. Recommend that a qualified contractor replace glass where necessary.

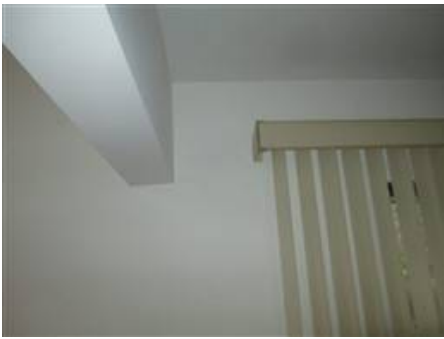
Photo 46-1

Minor cracks, nail pops and/or blemishes were found in walls and/or ceilings in one or more areas. Cracks and nail pops are common, are often caused by lumber shrinkage or minor settlement, and can be more or less noticeable depending on changes in humidity. They did not appear to be a structural concern, but the client may wish to repair these for aesthetic reasons. For recurring cracks, consider using an elastic crack covering product:

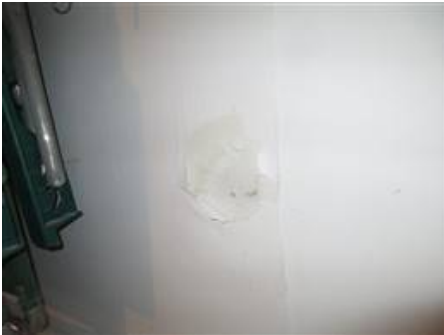
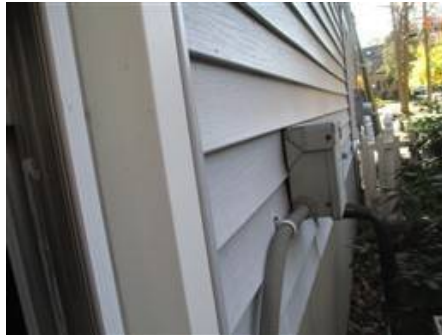
Patches or evidence of prior repairs were found in garage wall. Recommend asking the property owner about the repairs (e.g. why necessary, whether prior leaks have occurred).

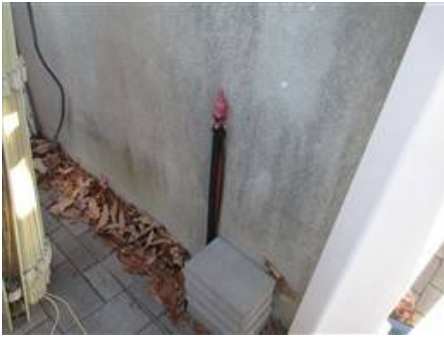
Photo X-1
Unknown wire protruding from ground near electric meter
