DE Home Inspections

Property Inspection Report

Property address: **Address**

Inspection date: **Thursday, January 01, 2009**

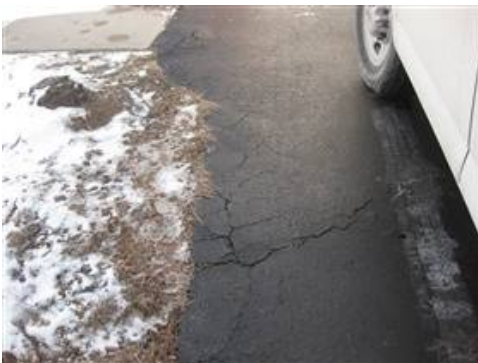
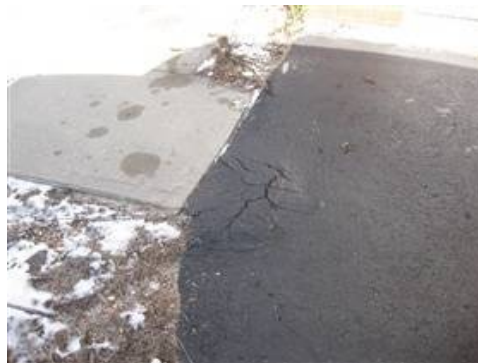
Cracks, holes, settlement, heaving and/or deterioration were found in the driveway. Recommend that qualified contractor repair as necessary.

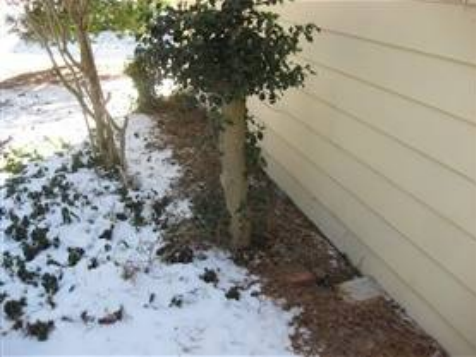
Photo 2-1

One or more large trees were very close to the foundation. Tree roots can cause significant structural damage to foundations. Recommend that a qualified tree service contractor or certified arborist remove trees as necessary to prevent damage to foundations.

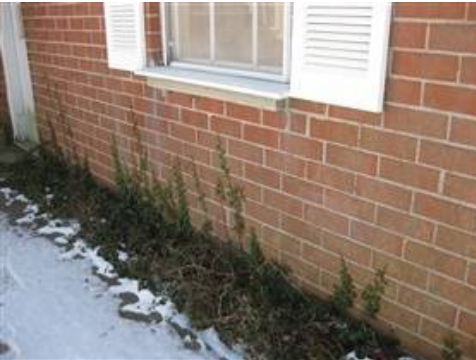
Photo 3-1

Vines were in contact with or close to the building exterior. Vegetation can serve as a pathway for wood-destroying insects and can retain moisture against the exterior after it rains. This is a conducive condition for wood-destroying organisms. Recommend pruning, moving or removing vegetation as necessary to maintain at least 6 inches of space between it and the building exterior. A 1-foot clearance is better.

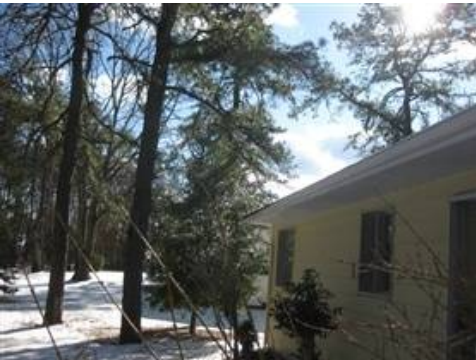
Photo 4-1

Trees were close to the building at one or more locations. Damage to the building can occur, especially during high winds. Recommend that a qualified tree service contractor or certified arborist remove trees as necessary to prevent damage to the building exterior.

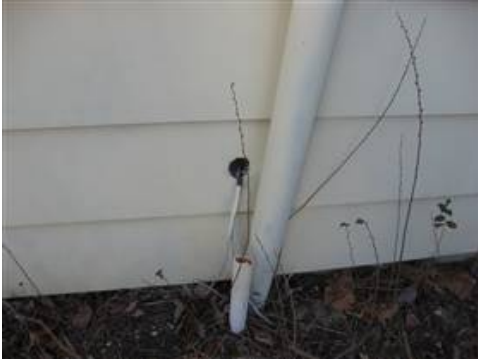
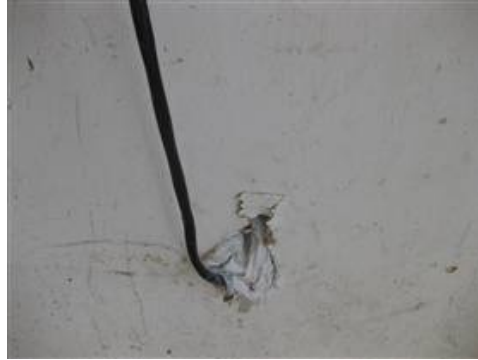
Caulk was missing in some areas. For example, at wall penetrations. Recommend that a qualified person renew or install caulk as necessary. Where gaps are wider than 1/4 inch, an appropriate material other than caulk should be used. For more information, visit: http://www.reporhost.com/docs/FPL_Caulking_Ins_Out.pdf

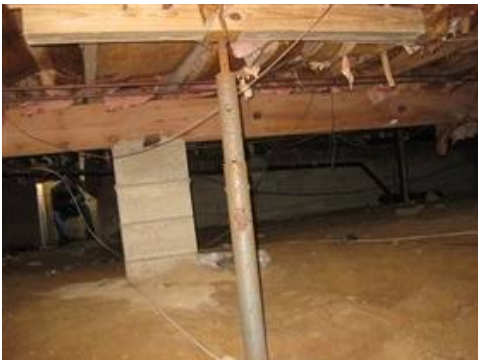
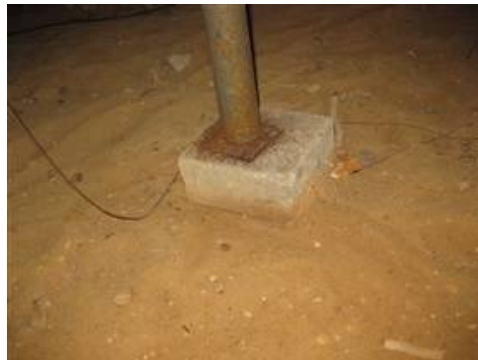
One or more adjustable steel columns were found. Some adjustable steel columns are rated for permanent use, but some are not. Based on the inspector's observations, columns in this building may not be rated for permanent use and may pose a safety risk for collapse. Recommend that a qualified contractor familiar with regulations surrounding use of such columns evaluate and repair if necessary, and per standard building practices.

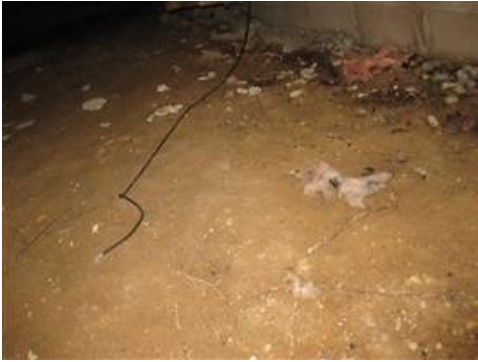
Photo 7-1

No vapor barrier was installed in the crawl space. This is a conducive condition for wood-destroying organisms due to the likelihood of water evaporating from the soil below up into the structure. A 6 mil black plastic sheet should be placed over all exposed soil with seams overlapped to 24 inches, and not in contact with any wood structural components. The sheeting should be held in place with bricks or stones, not wood. Recommend that a qualified contractor install a vapor barrier per standard building practices.

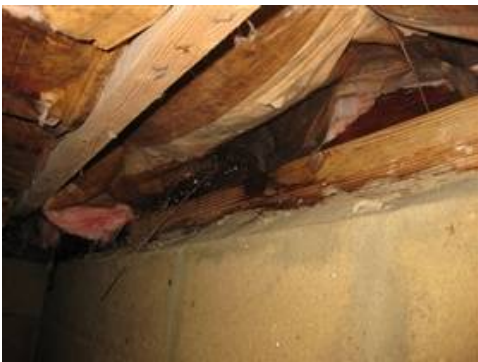
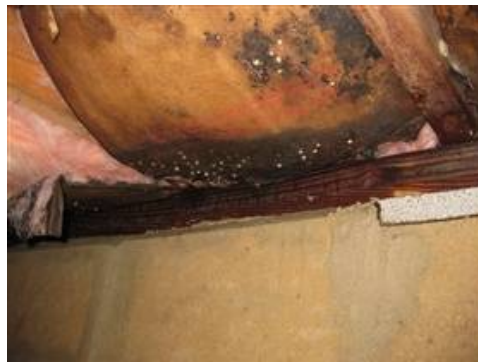
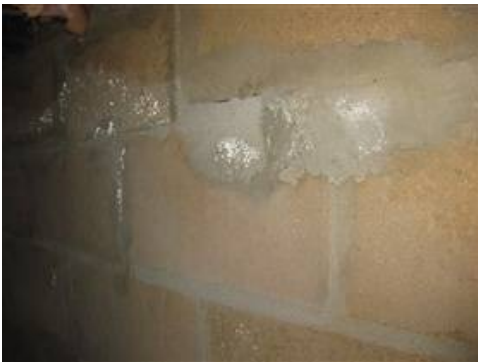
Ventilation for the crawl space was substandard. There was heavy condensation on the walls and all around the sill plate. This can result in high levels of moisture in the crawl space and is a conducive condition for wood-destroying organisms. One square foot of vent area should be installed for 150 square feet of crawl space. Vents should be evenly distributed and within a few feet of corners to promote air circulation. Recommend that a qualified contractor install or improve venting per standard building practices.

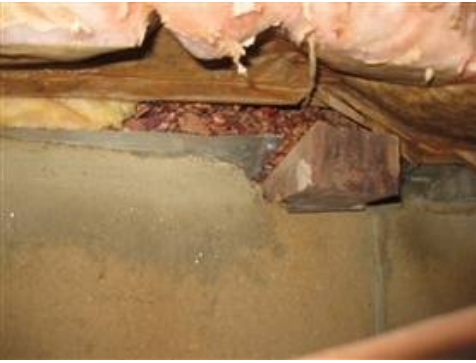
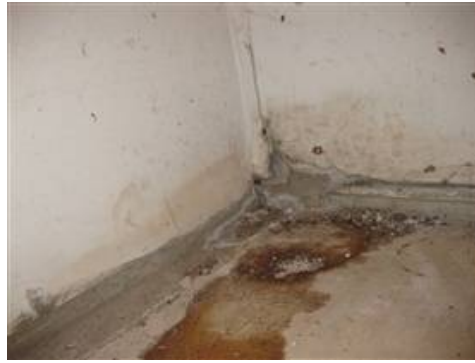
Evidence of rodent nesting was found in the crawl space. The access appears to be from the garage and the exterior hatch. Recommend a qualified person eliminate the access point.

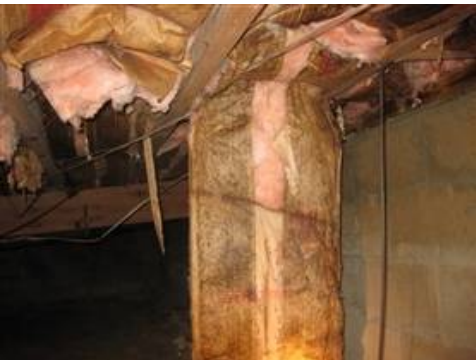
Photo 11-1

Some sections of under-floor insulation above the have fallen down. This may result in reduced energy efficiency. Recommend that a qualified person install or replace insulation as necessary.

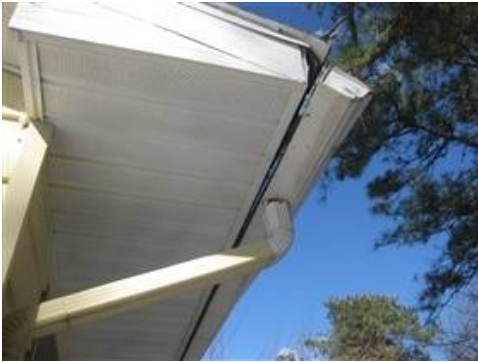
Photo 12-1

Water was leaking behind one or more gutters. Rainwater can come in contact with the building exterior or accumulate around the foundation as a result. The edge of the roof structure can become damaged by rot or water. This is a conducive condition for wood-destroying organisms. Recommend that a qualified person evaluate and repair as necessary. For example, by installing flashing or tightening loose gutters.

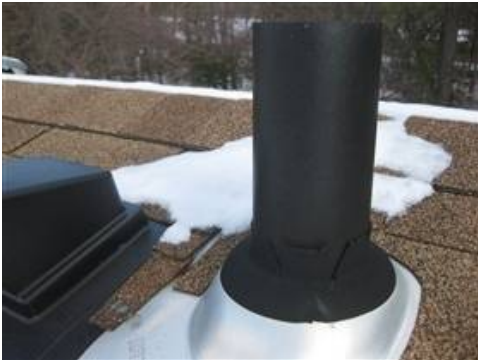
Photo 13-1

One or more rubber or neoprene pipe flashings were split or cracked. Leaks can occur as a result. This is a conducive condition for wood-destroying organisms. Recommend that a qualified contractor replace flashings where necessary.

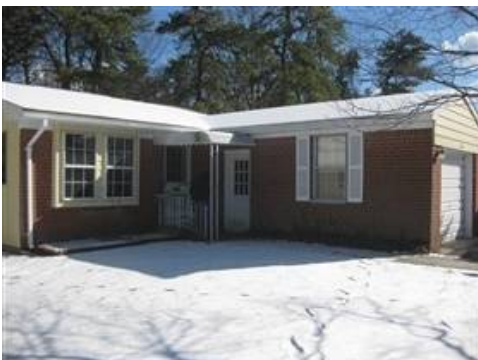
Photo 14-1

One or more gutters were very long and had too few downspouts. At least one downspout should be installed for every 30-40 feet of gutter. Too few downspouts may result in gutters being overwhelmed and then overflowing during heavy rain. Keep gutters clear of debris and monitor such gutters during periods of heavy rain. If they overflow, recommend that a qualified person install additional downspouts and extensions per standard building practices.

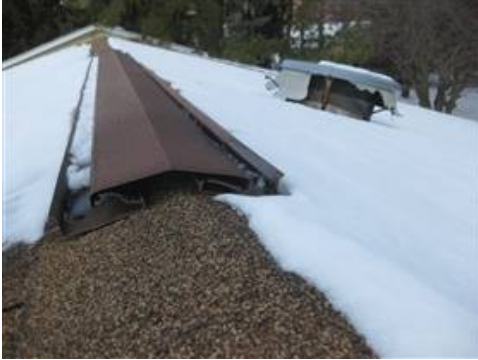
Photo 15-1

Some roof surfaces were obscured by snow and couldn't be evaluated. These areas are excluded from this inspection.

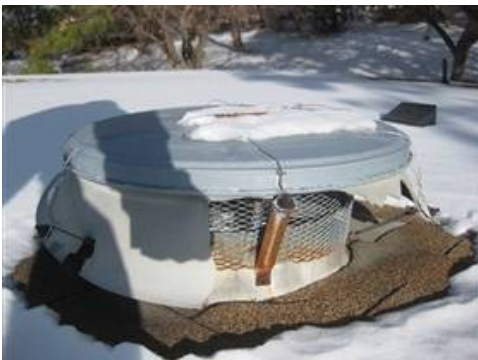
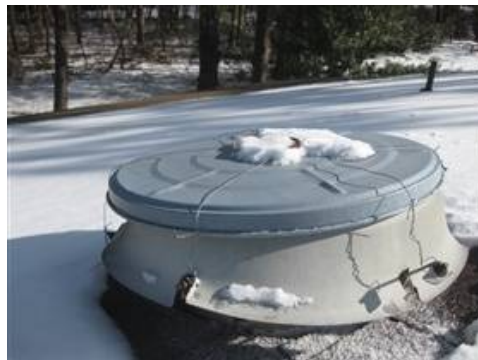
The outside cover on the attic fan was damaged and replaced with a garbage can lid. Recommend that a qualified person repair or replace as necessary.

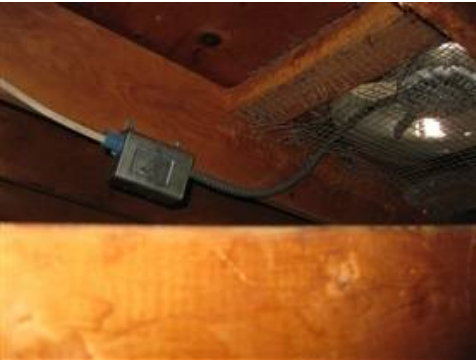
Photo 17-1

An attic exhaust fan was installed and controlled by a thermostat. However the inspector was unable to operate the fan or fully evaluate it because the temperature was too cool to activate the thermostat. It is excluded from this inspection.

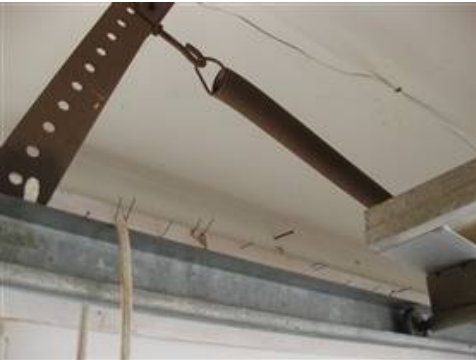
Photo 18-1

One or more extension springs supporting garage vehicle door springs had no safety containment cables installed. These cables prevent injury to people located nearby when springs eventually break. This is a potential safety hazard. Recommend that a qualified contractor install cables where missing per standard building practices. For more information, visit:

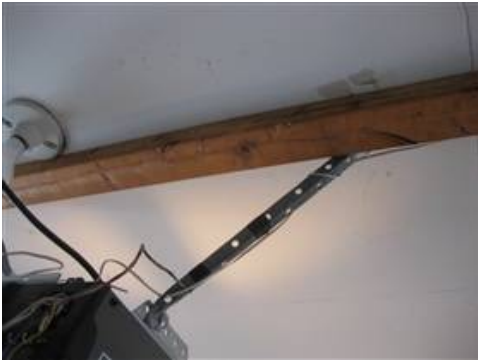
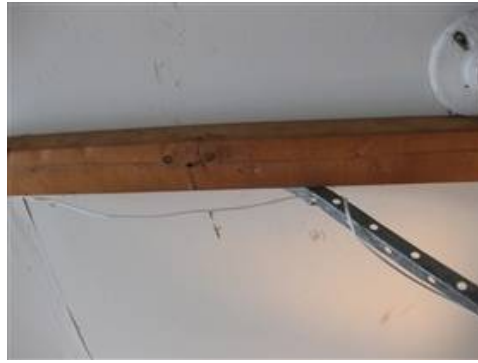
The automatic door opener was attached to a nailed in board. This is a substandard installation. Recommend that a qualified contractor evaluate and repair or replace opener(s) as necessary.

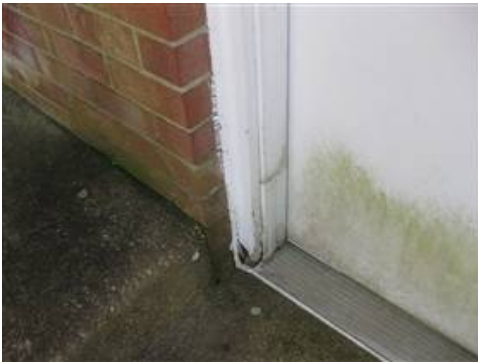
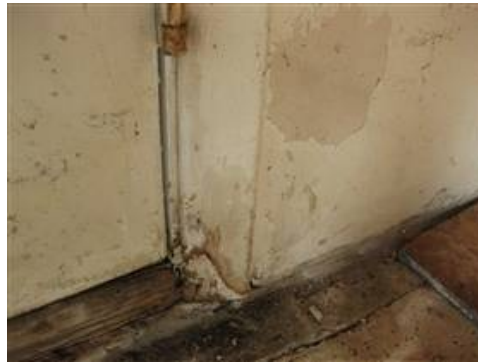
Fungal rot was found at one or more exterior door jambs. Recommend that a qualified person repair as necessary. All rotten wood should be replaced.

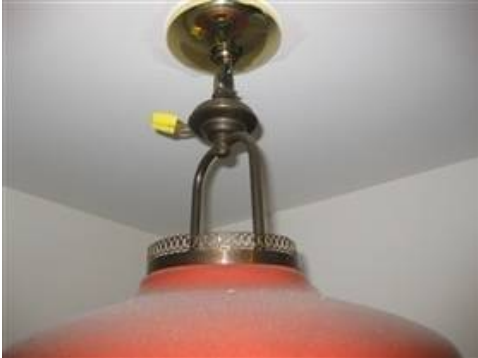
Photo 21-1

Wire splices were exposed and were not contained in a covered junction box. This is a potential shock or fire hazard. Recommend that a qualified electrician repair per standard building practices. For example, by installing permanently mounted junction boxes with cover plates where needed to contain wiring splices.

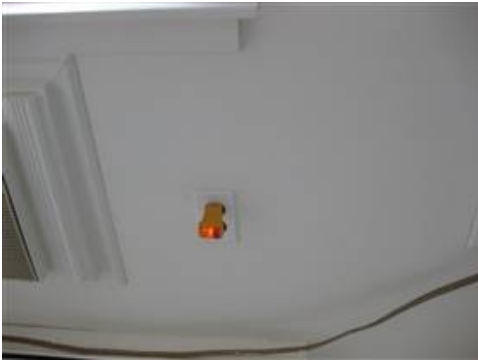
Photo 22-1

One or more electric receptacles (outlets) were incorrectly wired. Recommend that a qualified electrician repair as necessary.

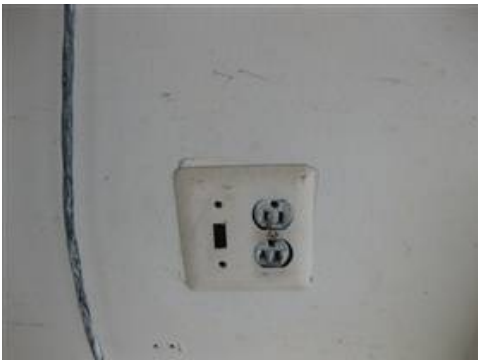
Photo 23-1

One or more cover plates for switches, receptacles (outlets) or junction boxes were missing or broken. These plates are intended to contain fire and prevent electric shock from occurring due to exposed wires. Recommend that a qualified person install cover plates where necessary.

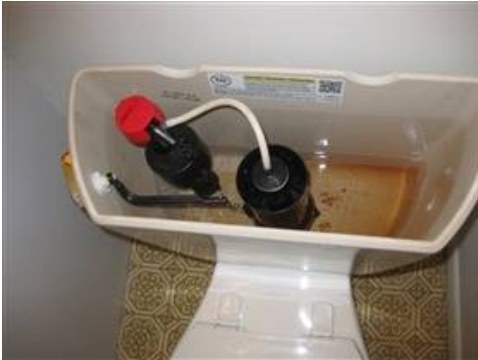
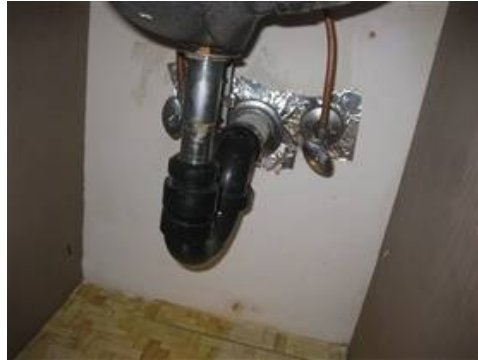
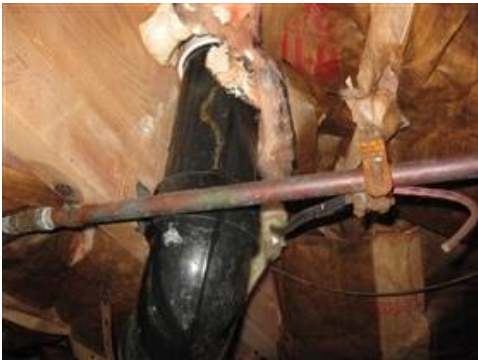
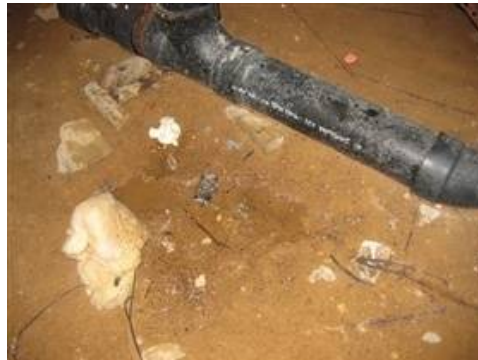
One or more leaks were found in drain, waste pipes or fittings. A qualified plumber should evaluate and repair as necessary.

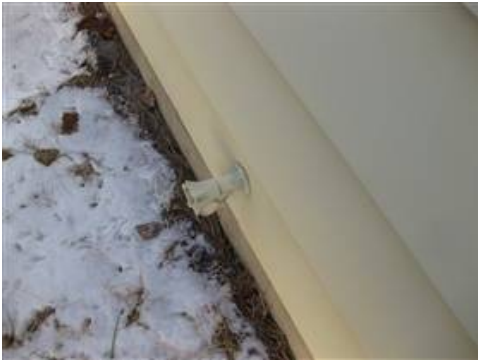
Photo 25-1

One or more hose bibs (outside faucets) appeared to be inoperable. Recommend consulting with the property owner about inoperable hose bibs, and if necessary have a qualified plumber make repairs.

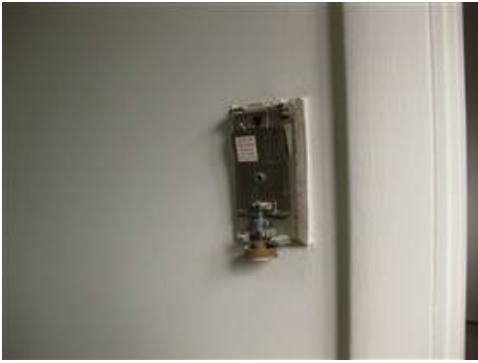
Photo 27-1

One or more electric wall heater thermostat covers were missing. A qualified electrician should evaluate and repair or replace heaters or thermostats as necessary.

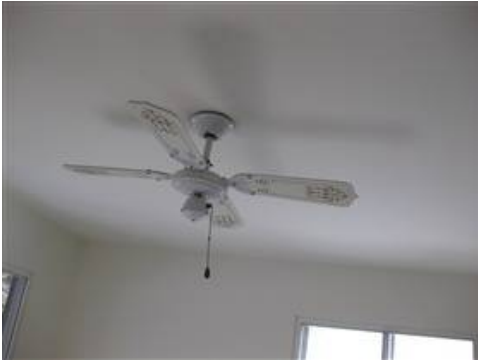
Photo 28-1

One of the ceiling fans appeared to be inoperable. Recommend that a qualified electrician evaluate and repair.

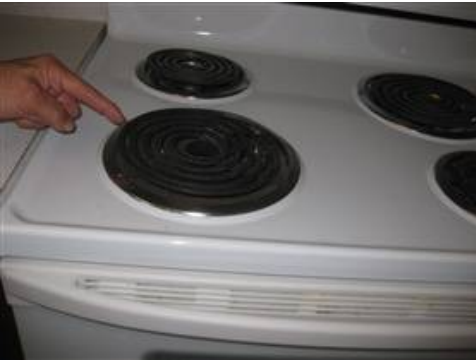
Photo 29-1

1 cooktop burner(s) were inoperable. Recommend that a qualified person repair as necessary.

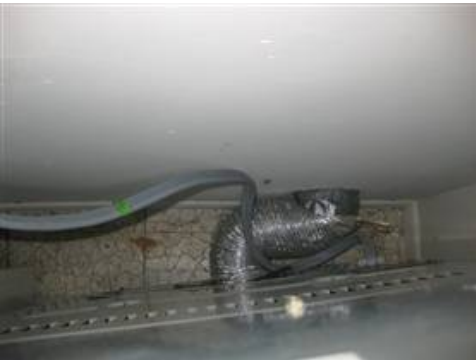
Photo 30-1

The clothes dryer exhaust duct was kinked, crushed or damaged. Air flow will be restricted as a result and the clothes dryer may overheat. This is a safety hazard due to the risk of fire. Recommend that a qualified person replace or repair the duct as necessary. For more information, visit:

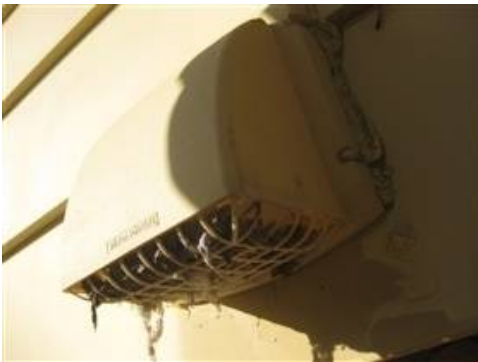
Photo 31-1

The clothes dryer exhaust duct appeared to need cleaning. Significant amounts of lint build-up were visible and may reduce air flow. This is a fire hazard. Recommend that a qualified person clean this duct now and as necessary in the future. Some chimney sweeps or heating/cooling duct cleaners perform this service. For more information, visit:

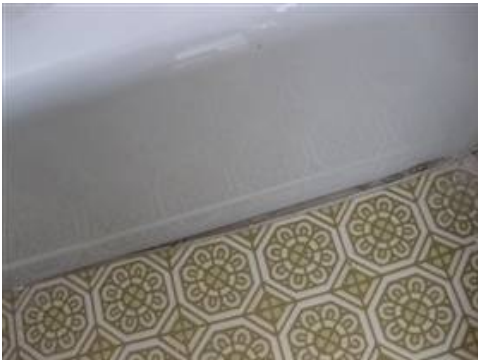
Photo 32-1

Vinyl flooring in the bathroom was damaged, deteriorated. Water can damage the the subfloor as a result. Recommend that a qualified contractor replace or repair flooring as necessary.

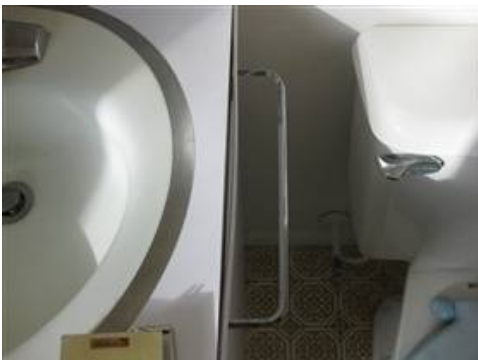
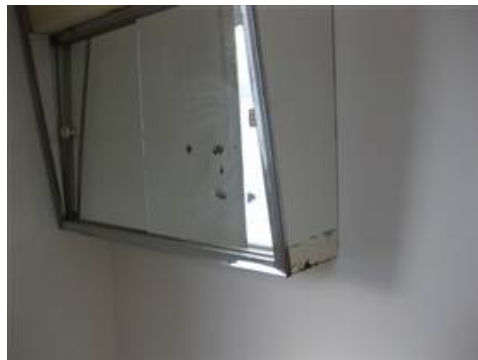
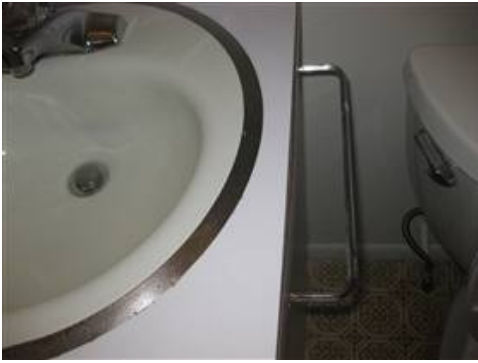
One or more cabinets, drawers and/or cabinet doors at location(s) #A, B were damaged or deteriorated. Recommend that a qualified person repair or replace as necessary.

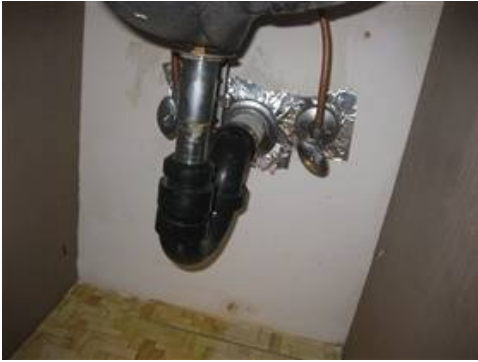
Photo 35-1

One or more sink drains were leaking at location(s) #A. A qualified person should repair as necessary.

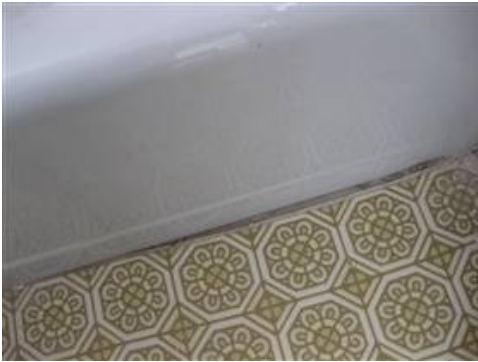
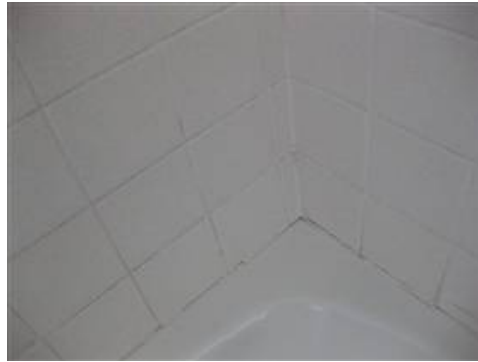
Gaps, no caulk, or substandard caulking were found between the bathtub and the floor, walls. Water may penetrate these areas and cause damage. Recommend that a qualified person re-caulk or install caulking as necessary.

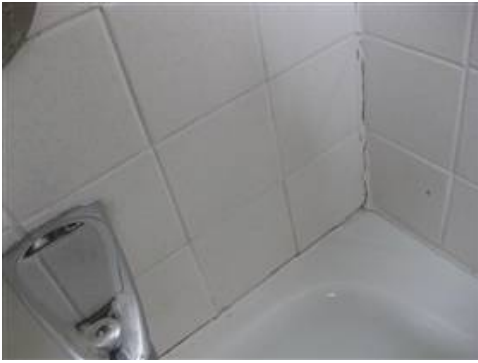
**Photo 37-1**

Tile and/or grout in the bathtub was deteriorated (e.g. loose or cracked tiles, missing grout) or substandard. Water can damage the wall structure as a result. Recommend that a qualified contractor repair as necessary.

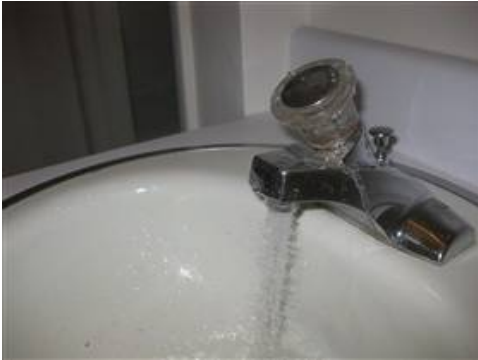
**Photo 38-1**

Water was leaking at the sink faucet base or handles at location(s) #A. Recommend that a qualified plumber repair as necessary.

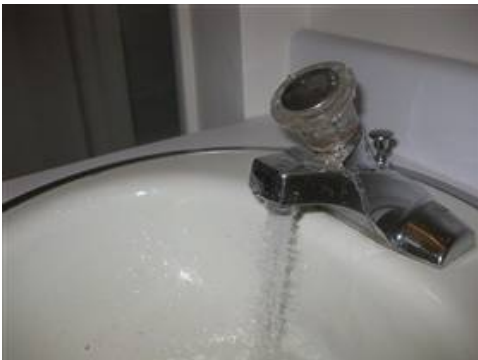
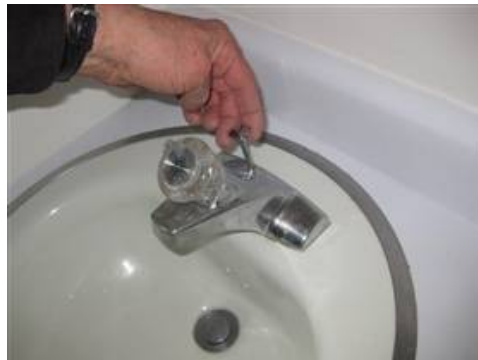
The sink drain stopper mechanism at location(s) #A, B was loose. Recommend that a qualified person repair or replace as necessary.

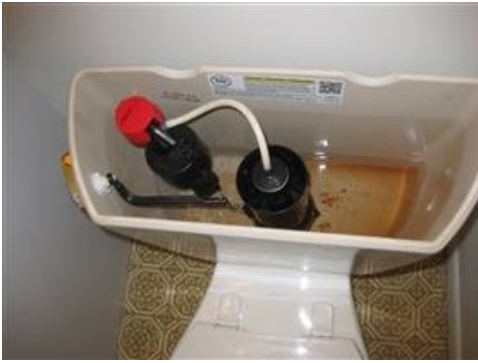
Photo 40-1

The toilet fill valve or float mechanism in the toilet at location(s) #A did not operate properly or was inoperable. Recommend that a qualified person repair as necessary.

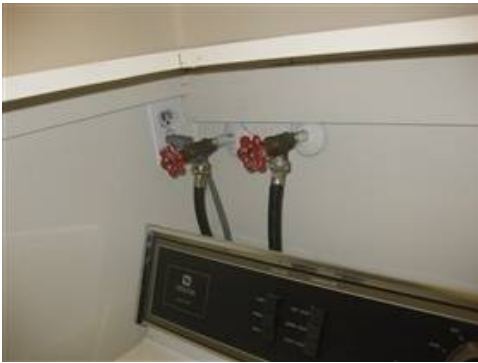
Photo 41-1

Rubber water supply hoses were installed at the clothes washer. These hoses are prone to bursting when deteriorated, which can result in flooding and significant water damage. Recommend upgrading to braided, stainless steel hoses.

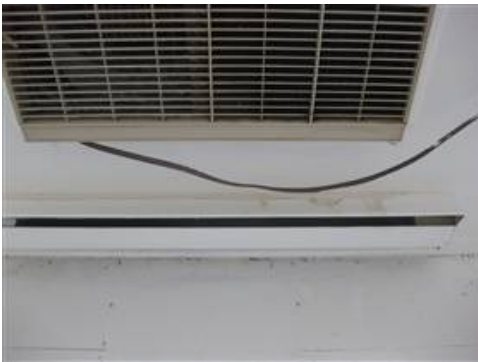
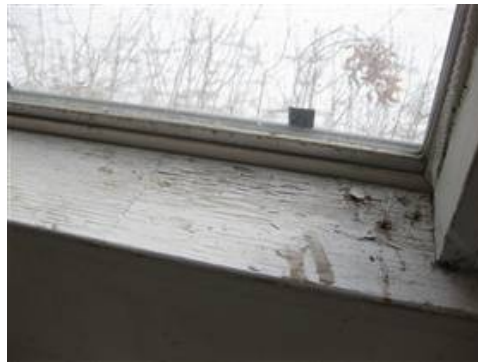
Water stains or evidence of leaking was found at one or more windows. Recommend that a qualified contractor evaluate and repair as necessary.

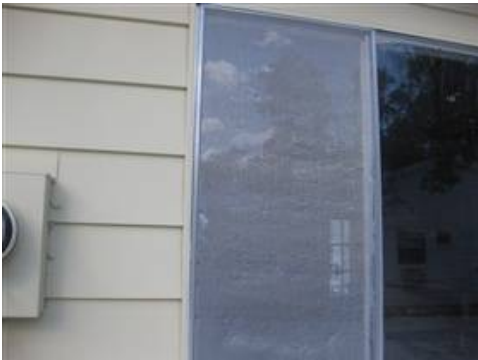
Photo 43-1

One or more window screens were damaged or deteriorated. These window(s) may not provide ventilation during months when insects are active. Recommend replacing window screens as necessary.

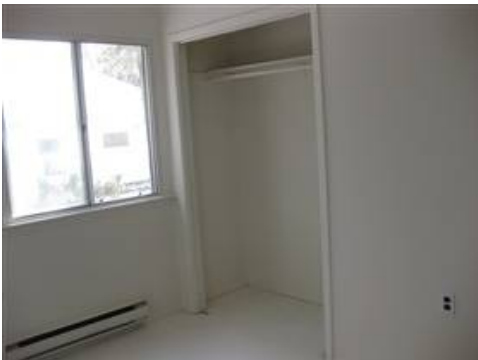
Photo 44-1

One or more interior doors were missing. Recommend that a qualified person replace or repair doors as necessary.

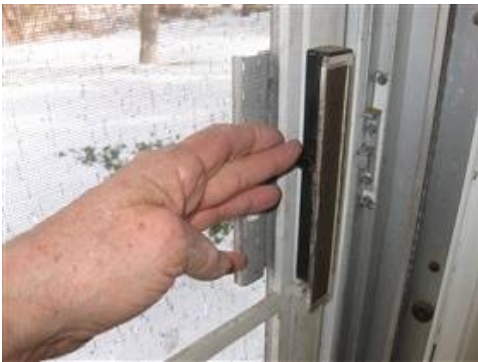
Photo 45-1

The lock mechanisms on the sliding scree door was inoperable. Recommend that a qualified person repair as necessary.

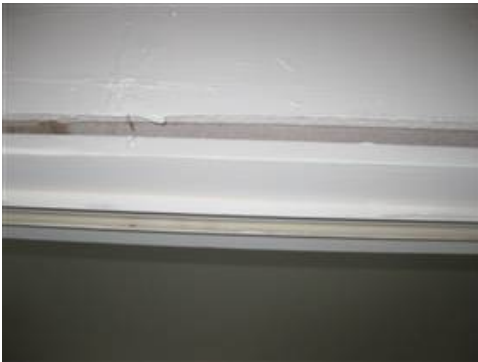
Photo 46-1

Trim was missing in one or more areas. Recommend that a qualified person repair as necessary.

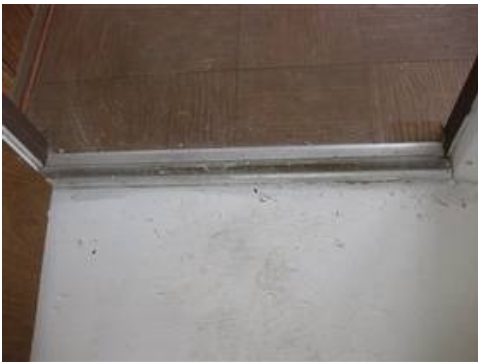
Photo 47-1

Weatherstripping at one or more exterior doors was deteriorated . Water may enter the building, or energy efficiency may be reduced. Recommend that a qualified person repair or replace weatherstripping as necessary.

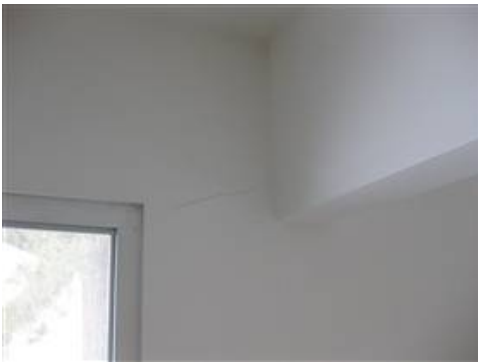
Photo 48-1

Minor cracks, nail pops and/or blemishes were found in walls and/or ceilings in one or more areas. Cracks and nail pops are common, are often caused by lumber shrinkage or minor settlement, and can be more or less noticeable depending on changes in humidity. They did not appear to be a structural concern, but the client may wish to repair these for aesthetic reasons. For recurring cracks, consider using an elastic crack covering product:

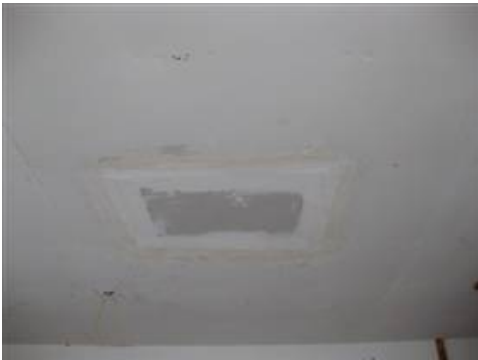
Photo 49-1

Patches or evidence of prior repairs were found in one or more walls or ceilings. Recommend asking the property owner about the repairs (e.g. why necessary, whether prior leaks have occurred).

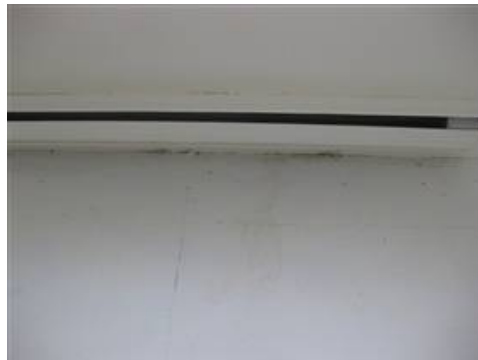
Stains were found in one or more floor areas. However, no elevated levels of moisture were found. Consult with the property owner and monitor the stained area(s) in the future. If elevated moisture is found in the future, then recommend that a qualified contractor evaluate and repair as necessary.

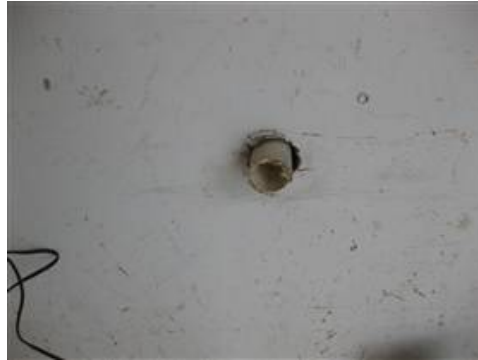
Photo X-2
uncapped pvc pipe in garage
