DE Home Inspections

Property Inspection Report

Client(s): **Client**
 Property address: **Client**
 Inspection date: **Thursday, January 01, 2009**

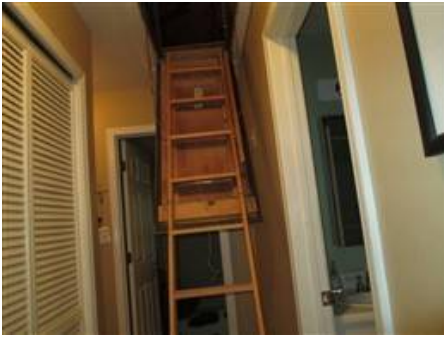
Photo 2-1

The pull-down attic stairs were not insulated. Typically, such stairs that are not insulated also do not have any weatherstripping installed. Recommend that a qualified person install insulation and weatherstripping per standard building practices for better energy efficiency. For more information, visit:

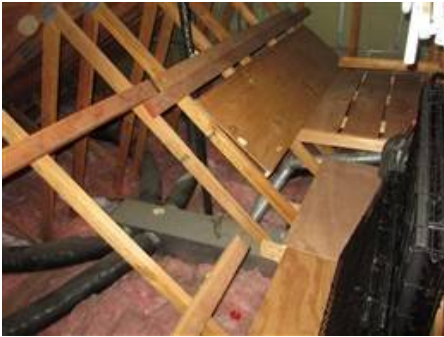
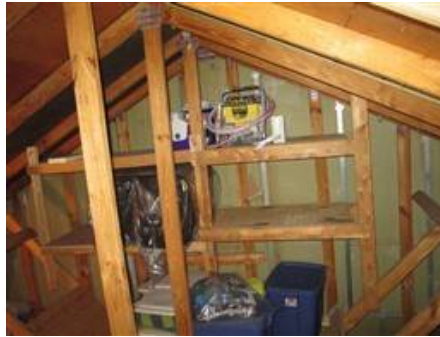
Photo 3-1

- 3) **i** Stored items and/or flooring for storage was found on roof trusses. Trusses are engineered components designed specifically for the load of the roof and possibly a snow load. Items should not be stored on roof trusses. Recommend removing flooring and/or stored items.

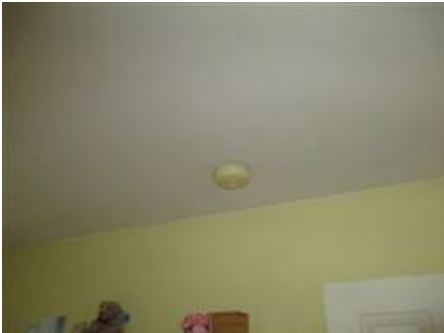
Photo 4-1

Based on the age of this structure and the appearance of existing smoke alarms, the alarms may have been installed more than 10 years ago. According to [National Fire Protection Association](http://www.nfpa.org), aging smoke alarms don't operate as efficiently and often are the source for nuisance alarms. Older smoke alarms are estimated to have a 30% probability of failure within the first 10 years. Newer smoke alarms do better, but should be replaced after 10 years. Unless you know that the smoke alarms are new, replacing them when moving into a new residence is also recommended by NFPA. For more information, visit: <http://www.google.com/search?q=old+smoke+alarms>

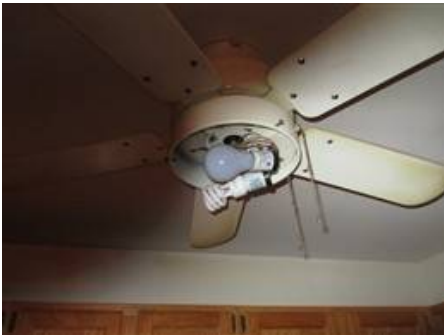
Photo 5-1

One or more globes or covers for light fixtures were missing or damaged. Recommend replacing as necessary to avoid exposed bulbs. With closet lighting or where flammable stored objects are near light fixtures, missing or broken covers can be a fire hazard.

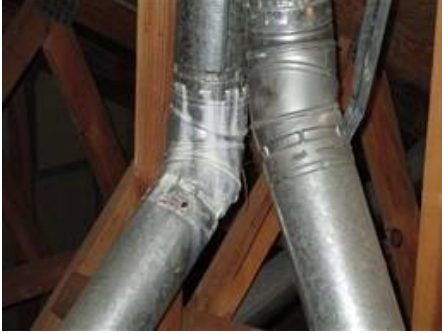
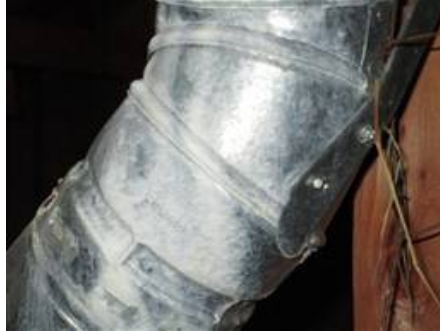
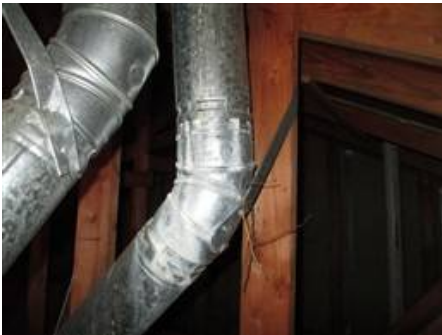
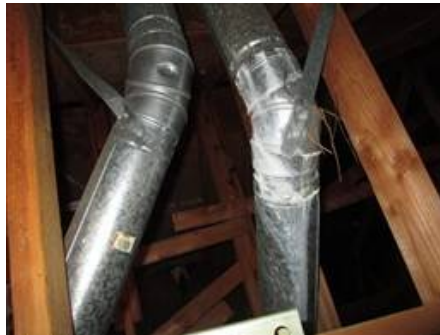
Photo 9-1

A significant amount of a white, powdery residue was found on or below the B or L vent exhaust flue. Typically this is a result of condensation in the flue and may indicate that the flue has a substandard draw. The flue may be incorrectly configured, blocked (e.g. debris, bird nest), or the appliance may be incorrectly configured. Recommend that a qualified contractor evaluate and repair as necessary.

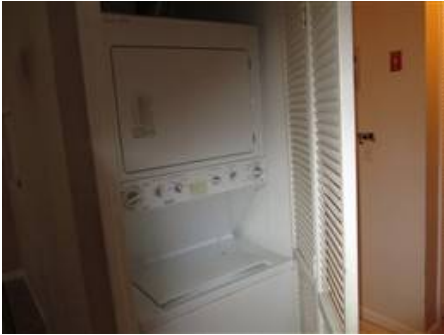
Photo 10-1

No accessible gas shut-off valve was visible within 6 feet of the gas-fired clothes dryer. This is a potential safety hazard when the appliance needs to be shut down quickly. Recommend that a qualified contractor install a shut-off valve per standard building practices.

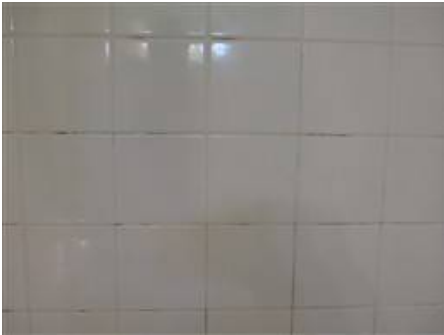
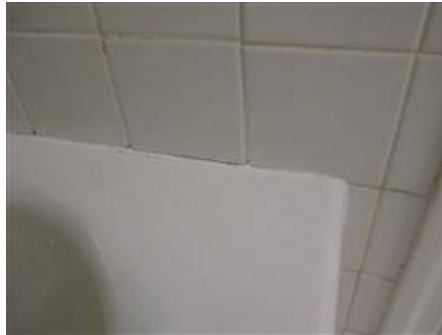
Photo 12-1

Tile and/or grout in the bathtub surround at location(s) #A was deteriorated (e.g. loose or cracked tiles, missing grout) or substandard. Water can damage the wall structure as a result. Recommend that a qualified contractor repair as necessary.

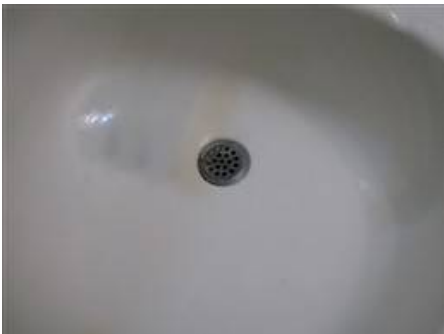
Photo 13-1

The sink drain stopper mechanism at location(s) #A was missing. Recommend that a qualified person repair or replace as necessary.

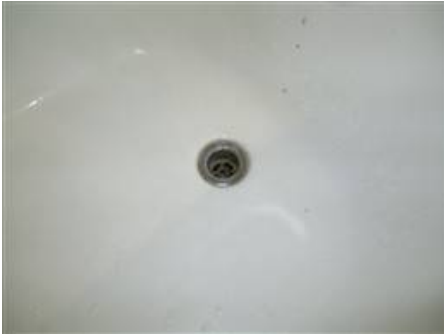
**Photo 14-1**

The bathtub drain stopper mechanism at location(s) #A was missing. Recommend that a qualified person repair or replace as necessary.

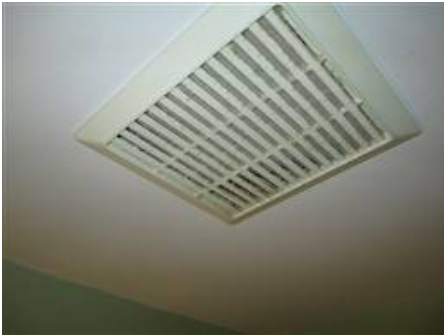
**Photo 15-1**

The exhaust fan or fan cover at location(s) #A needed cleaning. Dirty or clogged fans can result in moisture accumulation and subsequent mold, bacteria or fungal growth. Recommend cleaning fan covers or fans now and as necessary in the future.

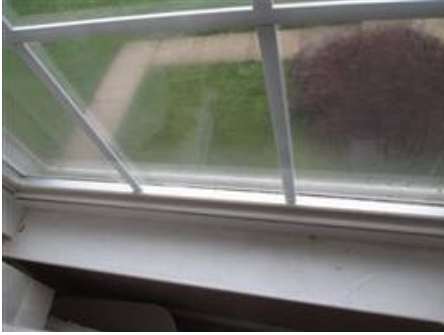
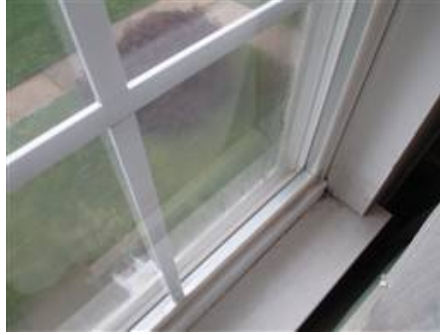
Photo 16-1

Condensation or staining was visible between multi-pane glass in one or more . This usually indicates that the seal between the panes of glass has failed or that the desiccant material that absorbs moisture is saturated. As a result, the view through the window may be obscured, the window's R-value will be reduced, and accumulated condensation may leak into the wall structure below. Recommend that a qualified contractor evaluate and repair windows as necessary. Usually, this means replacing the glass in window frames.

Be aware that evidence of failed seals or desiccant may be more or less visible depending on the temperature, humidity, sunlight, etc. Windows or

glass-paneled doors other than those that the inspector identified may also have failed seals and need glass replaced. It is beyond the scope of this inspection to identify every window with failed seals or desiccant.

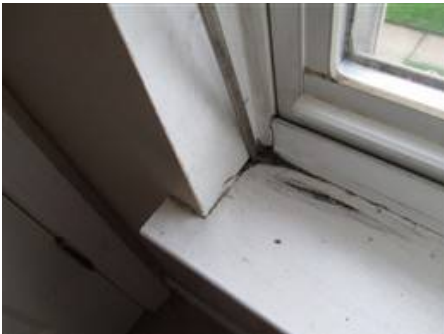
Photo 17-1

Water stains or evidence of leaking was found at one or more windows resulting in rotted wood damaged. Recommend that a qualified contractor evaluate and repair as necessary.

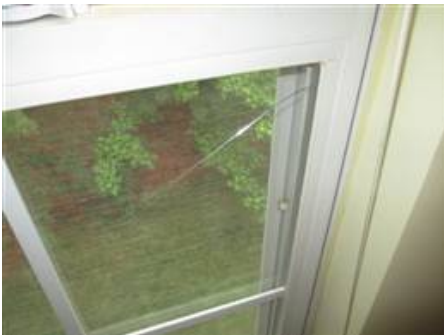
Photo 18-1

Glass in one or more windows was cracked, broken and/or missing. Recommend that a qualified contractor replace glass where necessary.

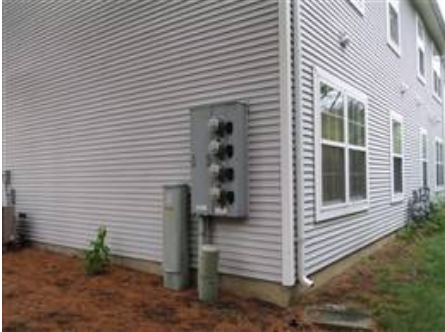
Photo X-1
Main Electric Shut-off

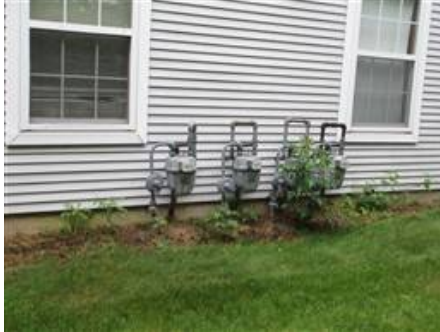
Photo X-2
Main Gas Shut-off

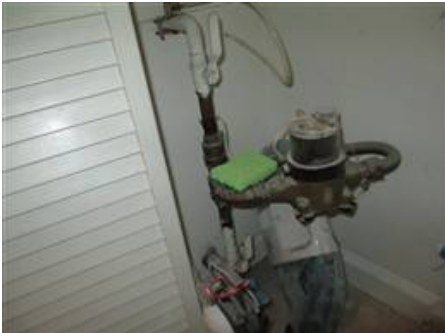
Photo X-3
Main Water shut-off and water meter
