DE Home Inspections

Property Inspection Report

Property address: **Address**

Inspection date: **Thursday, January 01, 2009**

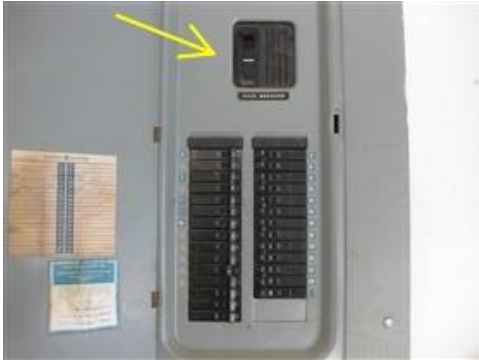
Photo X-1
Main electric shut off

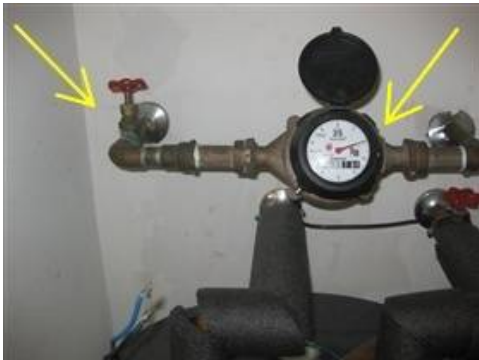
Photo X-3
Main water shut off and water meter

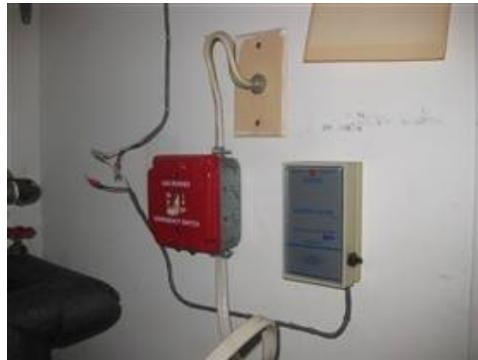
Photo X-4
Electric water heater shut off

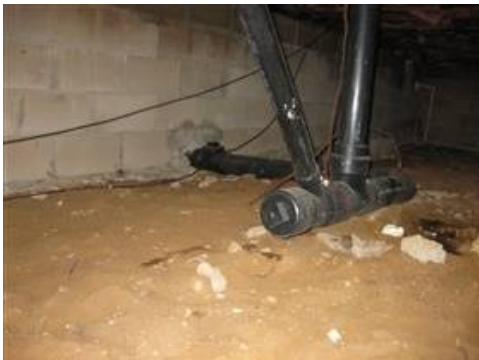
Photo X-5
Sewer cleanouts in crawl space
